# TRIP A-8

## A TOUR OF DAMAGE SITES AND A PROPOSED EPICENTER FOR THE CORNWALL-MASSENA EARTHQUAKE OF 1944

**Gary N. Nottis**

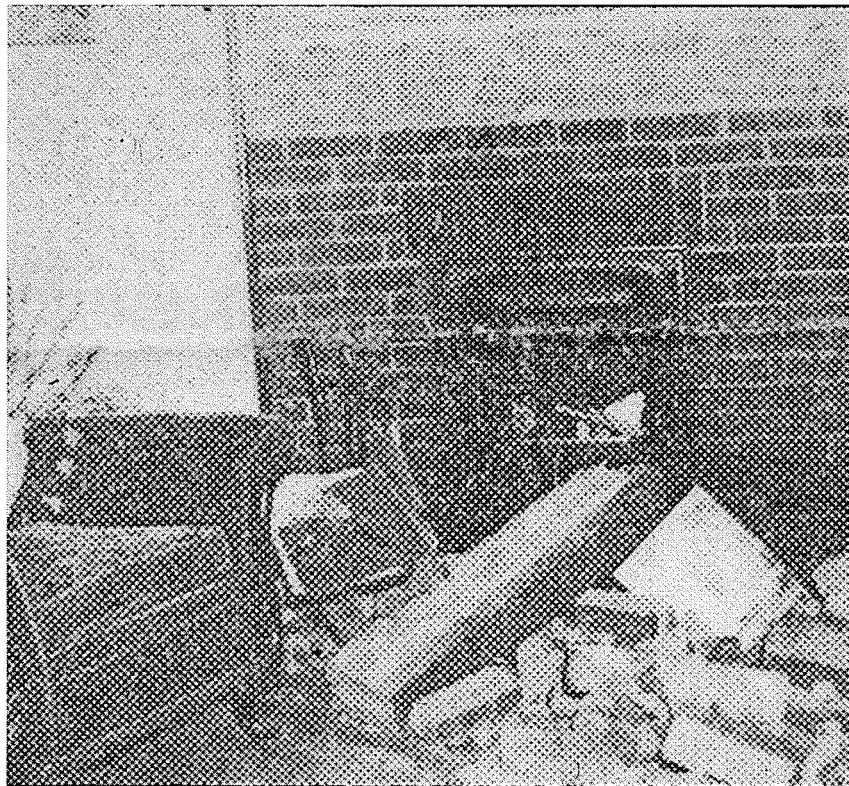
Residential chimneys not obviously damaged on the outside usually were damaged within the walls of residences. Damaged chimneys and fireplaces posed a significant fire hazard. Figure 4 shows an example of a damaged fireplace. In spite of the onset of cold weather following the earthquake, home owners were asked not to use their fireplaces until chimneys could be repaired or inspected. The mayors of both Massena and Cornwall were pressed to find enough materials and skilled workers to complete repairs of chimneys before winter.

Figure 4. Damaged fireplace in the home of Mr. and Mrs. Charles G. Stubbs, 16 Danforth Place, Massena, New York (Tour Stop #2). The photo is from page 1 of the September 8, 1944 *Massena Observer*

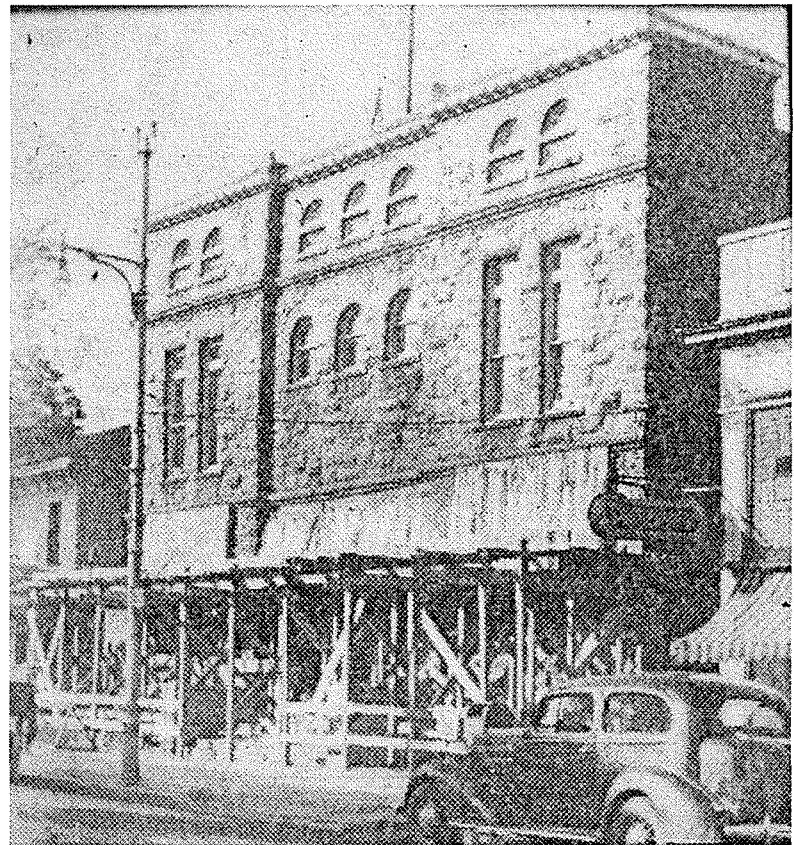
Figure 5. Repair work being done to the front stone work of the Massena Town Hall. The stone work bulged outward on the front bottom third as a result of the earthquake. The picture is from page 14 of the September 18, 1944 *Watertown (NY) Daily Times* (Tour Stop #10).

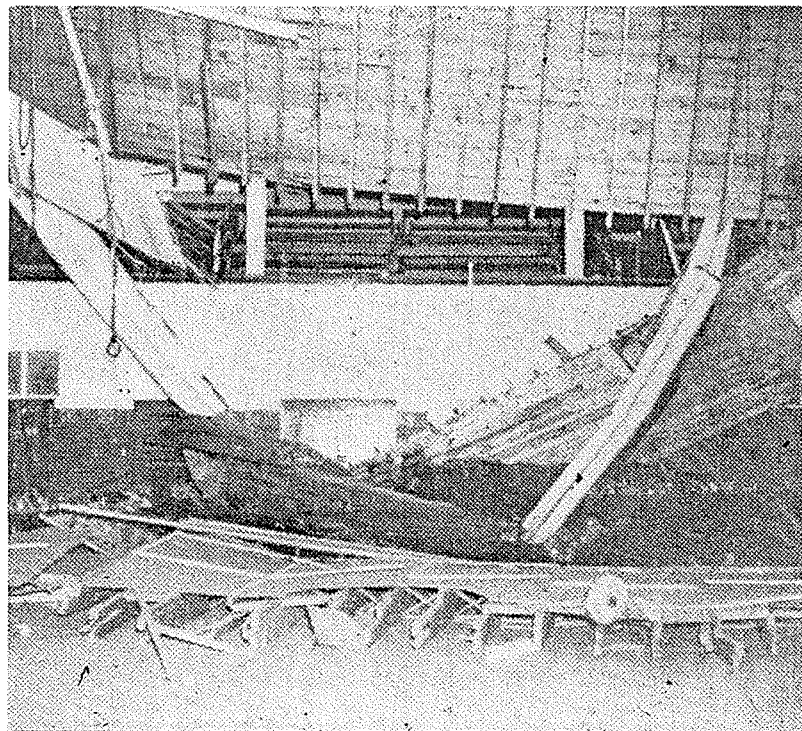
In Cornwall the Collegiate and Vocational School and the Public School were extensively damaged. The Collegiate and Vocational School had structural and non-structural damage. Large portions of brick coping on the middle section of the school were shaken loose in the front and back. One section of brick coping broke loose and fell through the timber roof of the girl's gymnasium. That damage is shown in Figure 6. The school's main chimney was badly damaged, cracks developed in the brick walls, and considerable plaster fell inside the school.

Figure 6. Destroyed timber roof of the girl's gymnasium at the Cornwall Collegiate and Vocational School in Cornwall, Ontario. A portion of exterior brick coping broke loose from the back of the school and fell through the roof. Photo is from Lamontagne and Bruneau (1993).

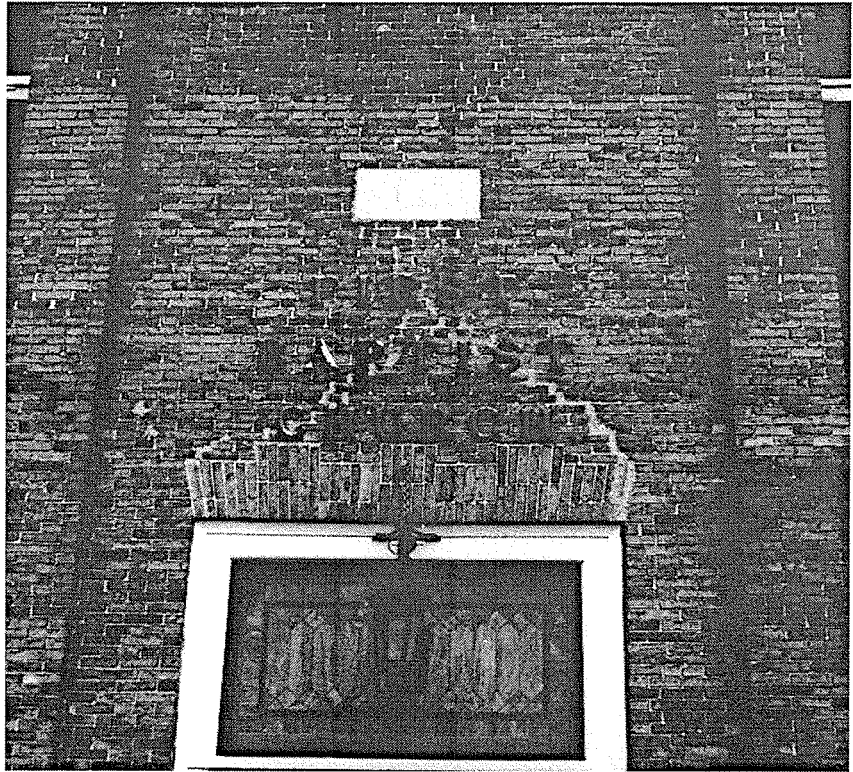
**Churches.** Most churches in the epicentral area had plaster and chimney damage as a result of the September 5<sup>th</sup> earthquake. The First Baptist Church in Massena had some minor cracking of the brick walls at various points (refer to Figs. 7 and 8). The majority of damage was confined to cracked interior plaster, especially bad in the sanctuary. St. John's Episcopal Church experienced glass and plaster damage along with damage to the marble altar. Brick supports within the altar collapsed and allowed the marble to shift. One church at Massena Center suffered structural damage and was eventually torn down.

Figure 7. Cracked brick work above the main door to the First Baptist Church in Massena, corner of Main Street and East Orvis Street in Massena (Tour Stop #9). The cracks above the entrance are about 1" to 2" wide. This photo was taken in 1993.

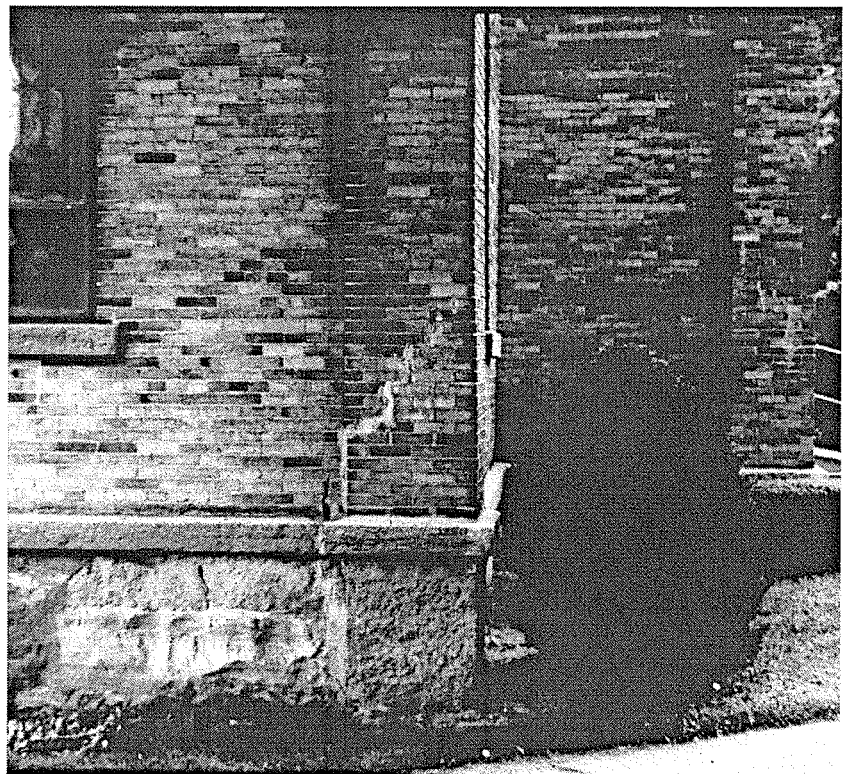
Figure 8. Cracked brick work on the lower north side wall of the First Baptist Church near the front of the building. The crack is generally 2" wide. Photo was taken in 1993.

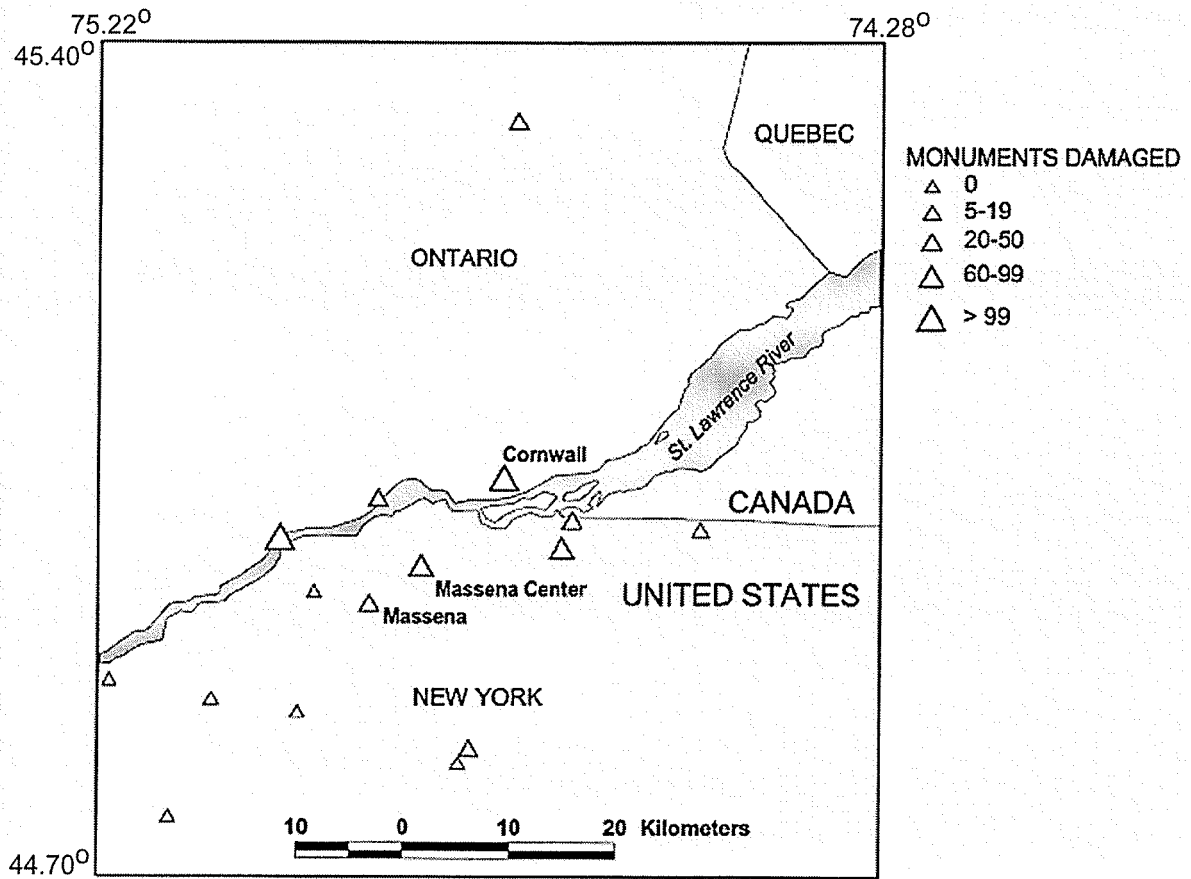
**Cemetaries** A number of cemeteries in the Cornwall and Massena area had damage to monuments or gravestones. Of 30 cemeteries visited by investigators following the earthquake, 13 had monuments that had markedly rotated, shifted, or fallen over. Figure 9 gives an idea of the distribution of the cemetery monument damage. Those monuments that were composed of more than one part sometimes had individual parts rotated in opposite directions. An interesting feature of the cemetery damage is that the majority of monuments on the Canadian side of the St. Lawrence River had counter-clockwise rotations, while those on the American side had clockwise rotations. It should be noted that the numbers of monuments damaged and the degree of damage generally increased as one approached the area containing Massena Center, NY and Cornwall.

Figure 9. Distribution of some cemeteries investigated for damage following the 1944 Cornwall-Massena mainshock along with total numbers of damaged monuments at each locality. The numbers of monuments damaged and the degree of damage generally increased as one approached the area containing Massena Center, NY and Cornwall.

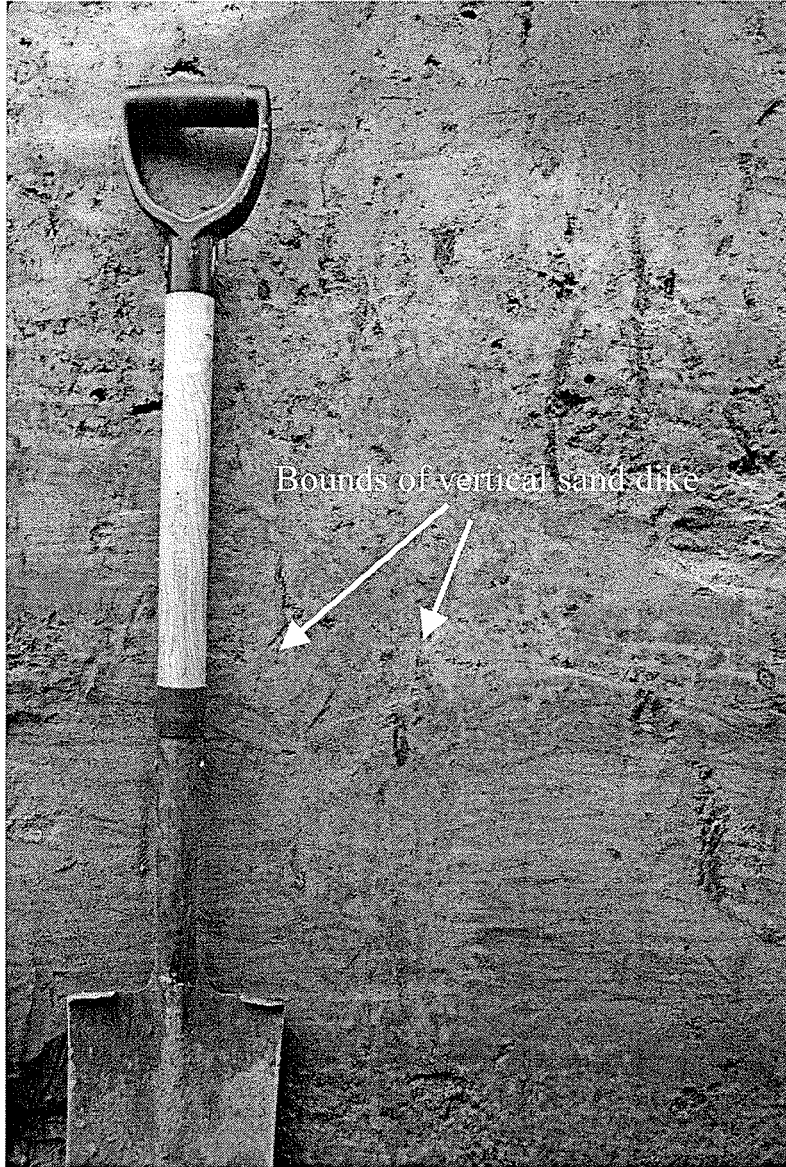
A definite occurrence of liquefaction took place at the W.G. Hooper Farm, about 2 km northwest of Massena Center. In the yard behind the farmhouse two north-south trending fissures of about 1" to 2" in width and up to 100' in length opened and white sand and water flowed out (Berkey, 1945). A third fissure from which sand and water flowed was found about 300' to the west across the local road. A back-hoe investigation of the farm site in the early 1990s by Tish Tuttle and Noel Barstow of the Lamont-Doherty Earth Observatory of Columbia University found sand dikes and diapers formed by the liquefaction of a 4' thick layer of white sand lying 8' beneath marine clays and silts. A photo of a sand dike at the Hooper Farm site is presented in Figure 10.

Figure 10. Sand dike found in trench at the site of the former William G. Hooper farm, Massena Center, New York (Tour Stop #15). Shovel is for scale. Note disrupted soil structure defining the sand dike. Photo is courtesy of Tish Tuttle.
