Trip B-3

MONITORING COASTAL CHANGE: EASTERN LAKE ONTARIO

SHARON L. GABEL¹, JOHN DEHOLLANDER², ROBERT VENCZEL¹, DAVID WHITE³

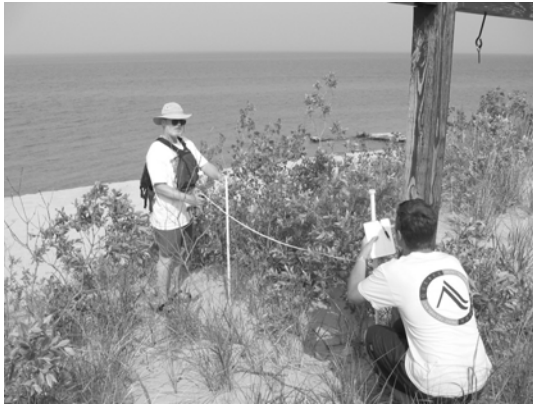
Figure 4 - Emery technique used to measure beach profiles.

Beach profiles were measured monthly during snow-free months (April or May through November) at 5 locations along the sandy eastern Lake Ontario shoreline (Fig. 2; Table 1) using the Emery method (Morisawa and King, 1973; Fig. 4). The Selkirk profiles were measured on private land just north of the mouth of the Salmon River, at the southern end of sandy barrier system. This portion of the shoreline has been extensively developed, with closely-spaced cottages built atop vegetated aeolian dunes (Fig. 5a). The beach at Selkirk is coarser-grained than the other beaches, with gravel-sized sediments dominating on the swash face. At other localities, mean grain size of beach sediments is fine sand. The Sandy Island Beach locality is now a state park, and the profile was measured on the public beach (Fig. 5b). This area lies at the south end of a zone of very tall dunes vegetated by dune grasses, bushes and mature trees. Some residences were built atop some of these dunes. At Montario Point, beach profiles were measured just north of a small inlet that connects South Colwell Pond to Lake Ontario. This beach is undeveloped, and the dunes at this location are not as tall as at Sandy Island (Fig. 5c). The profiles at Southwick Beach State Park were measured just south of the park boundary in the Lakeview Wildlife Management Area (Fig. 5d). The Eldorado site (Fig. 5e) lies just north of an area of closely-spaced cottages, but within the undeveloped Black Pond Wildlife Management Area. The profile locations at Southwick Beach and Eldorado begin on low dunes vegetated by shrubs and mature trees. At all 5 profiling locations, a datum was installed and its location and elevation relative to mean sea level was surveyed. Profiles were made from the datum along transects oriented perpendicular to shore. Profiles extended into the water until water depths became to great for wading. During cold months, the profiles ended at the water edge. In 2004, a program of surveying profiles to greater water depths was begun. Water depths were measured from a boat and the boat location was measured using an electronic distance meter. The plan is to measure profiles twice per year, at higher and lower lake levels.

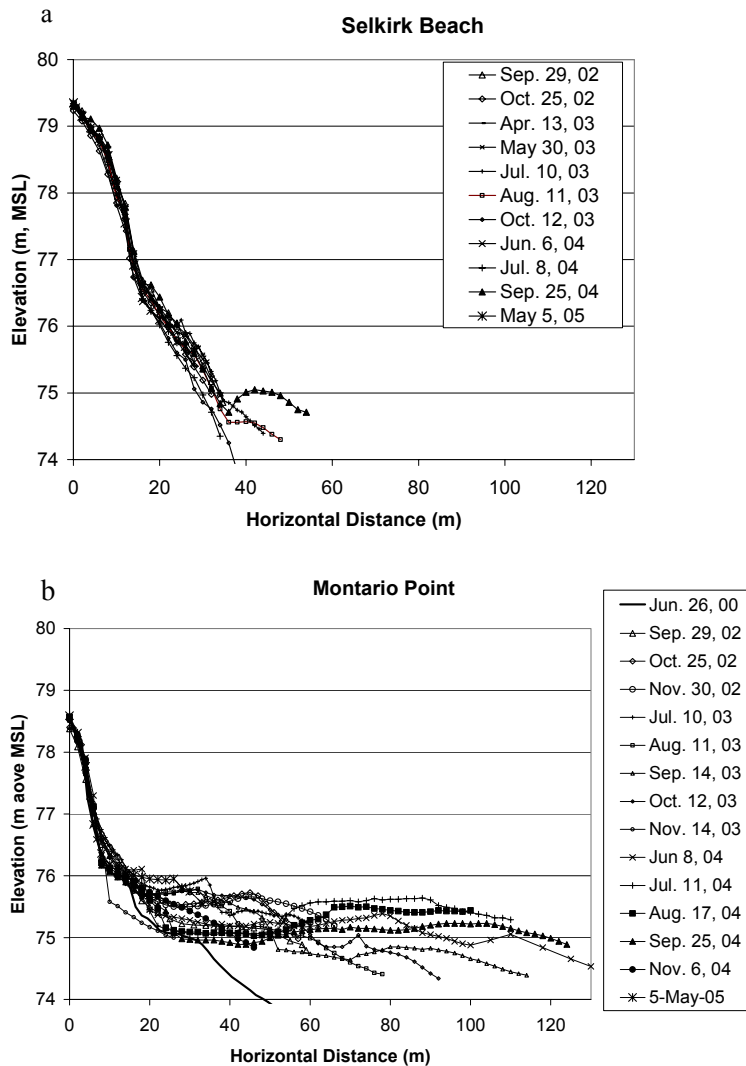
Figure 6 - Examples of graphs comparing all beach profiles measured at a particular location. a) The gravelly beach at Selkirk show very little variation in profile shape over time. b) The beach at Montario Point showed the greatest variability in profile shape during the study period.

Monthly beach profiles were plotted for each of the 5 locations. There was good agreement among profiles taken at each location (Fig. 6), showing that the Emery technique generally yielded satisfactory results. The Selkirk (Fig. 6a) profiling locality showed the least variation in profile shape during the study period. This is to be expected, as Selkirk Beach is the coarsest-grained. The profiles at Montario Point showed the greatest variability (Fig. 6b), as this locality was affected more strongly by storm surge and perhaps due to its proximity to an inlet. All locations show seasonal changes in profile shape. Storms caused changes in profile shape at some locations. Longer-term changes in beach profiles are subtle. All of these changes are described below.

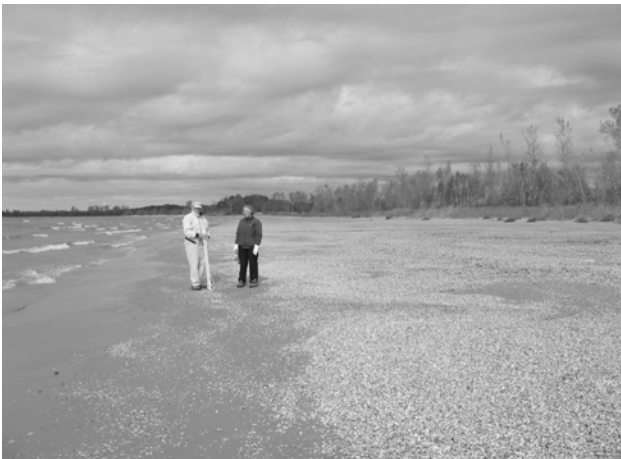
Figure 8 - Zebra mussel shells deposited during the windstorm of Oct. 15, 2003. Photo was taken on Oct. 18, 2003.

The October, 2003 wind storm had little effect on Southwick Beach, but on Eldorado Beach, a large accumulation of zebra mussel shells was deposited as a result of the storm (Fig. 7). In places, the mussel shells formed accumulations more than 0.2m thick. Zebra mussels flourish on the bedrock at the lake bottom just a few hundred meters offshore as well as in shallow water along the rocky coast to the north. Therefore, it is fairly common to find smaller accumulations of mussel shells at Eldorado in the springtime, probably due to deposition from melting ice. Zebra mussel shells are found on all beaches, but in much smaller numbers.

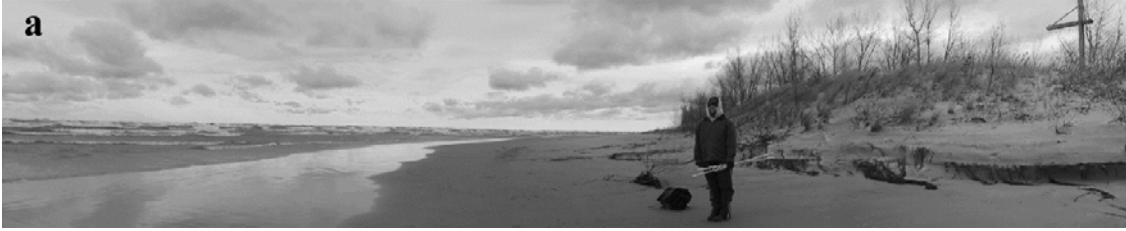
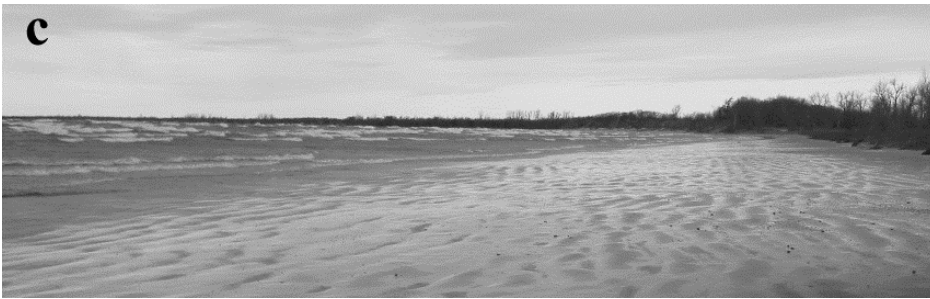
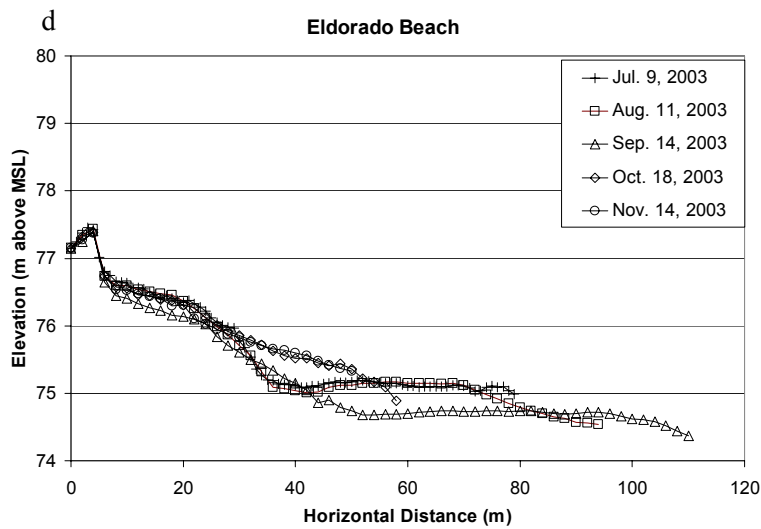
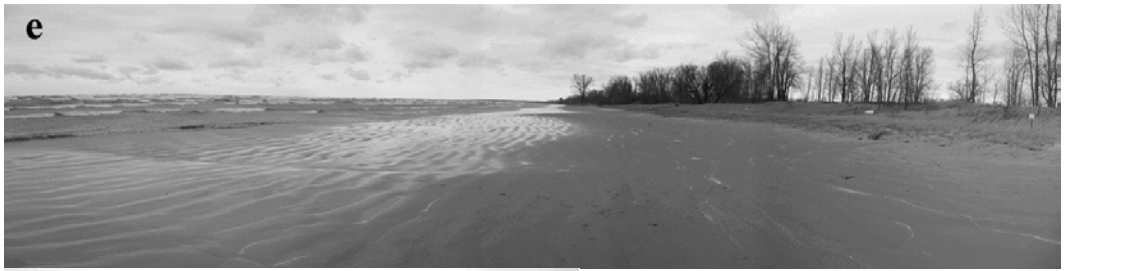
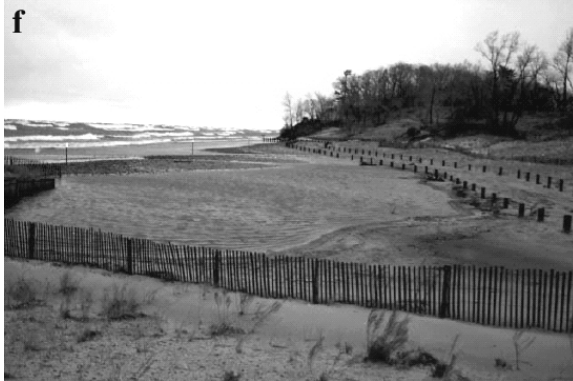
Figure 9 - Effects of windstorms on eastern Lake Ontario beaches. a) Montario Point beach, on Nov. 14, 2003. Note scarp at base of dune. b) Montario Point profile measured on November 14, 2003 shows erosion on the beach and lower dune slope. c) Wave ripples on Eldorado beach, November 14, 2003. d) Eldorado beach profile for November 14, 2003 is similar to the one measured in October. e) Southwick Beach State Park on Nov. 14, 2003. f) Sandy Island Beach at the height of the wind storm on Nov. 13,

2003 (photo courtesy S. Bonanno), and g) the following day. h, i) Comparisons of beach profiles measured on Nov. 14, 2003 with previous profiles measured at Southwick and Sandy Island Beaches, respectively.

The larger, November, 2003 windstorm also affected some beaches more dramatically than others. The greatest impact of the November storm occurred at Montario Point where waves eroded the beach and the base of the dune (Fig. 8a, b). Wave ripples were observed on the beach at Eldorado (Fig. 8c) and Southwick (Fig. 8e) beaches, indicating that water had covered much of beach to some depth, but beach elevations were only slightly altered (Fig. 8c,h). Storm surge also inundated Sandy Island Beach (Fig. 8f), and cobbles were observed over much of the beach following the storm (Fig. 8g). However, the November profile at Sandy Island Beach was similar to the October profile, except that the beach face increased in elevation in November relative to October (Fig. 8i).

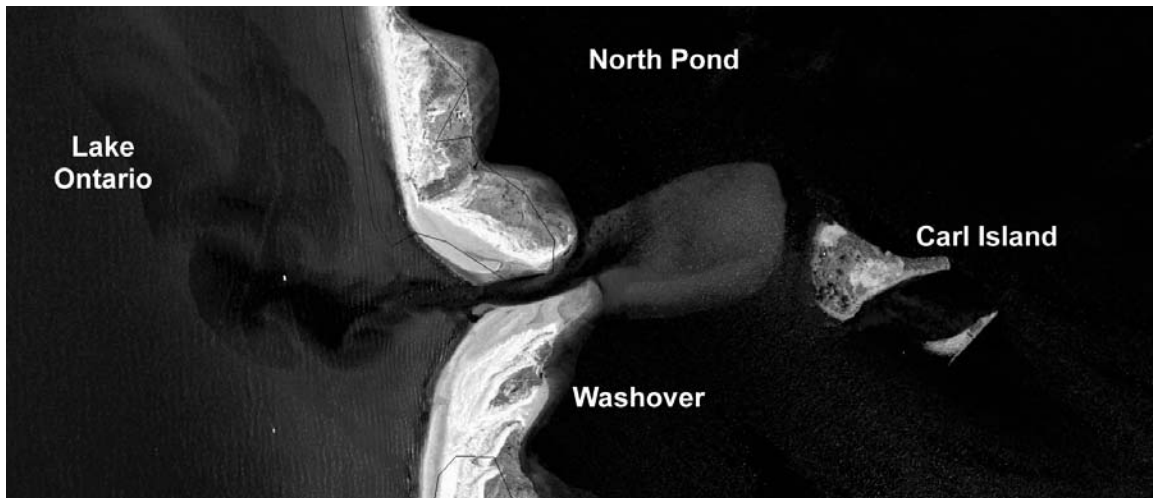
Figure 12 - Aerial photograph of Sandy Pond Inlet, April 2003, north to top of photo. Note sand shoal on pond side of inlet. Source: NY GIS Clearinghouse (n.d.).

Sandy Pond Inlet connects North Pond to Lake Ontario (Fig. 12). Boaters use the sandy beach on the north side of the inlet for sunbathing and picnicking. The vegetated area and low dunes just south of the inlet channel is a bird sanctuary, and access is restricted. Farther south, there is a washover channel and fan just south of the line of low dunes closest to the inlet. This area is used for boaters to walk from the pond side to the lake side for swimming and sunbathing (Fig. 13). During late summer, declining lake level and deposition in the inlet channel make it increasingly difficult for larger boats to navigate through the channel as the season progresses. The area between the inlet and Carl Island becomes shallow and difficult to navigate as well. In 2004, a group of private citizens obtained permits to dredge the inlet in order to maintain channel navigability.

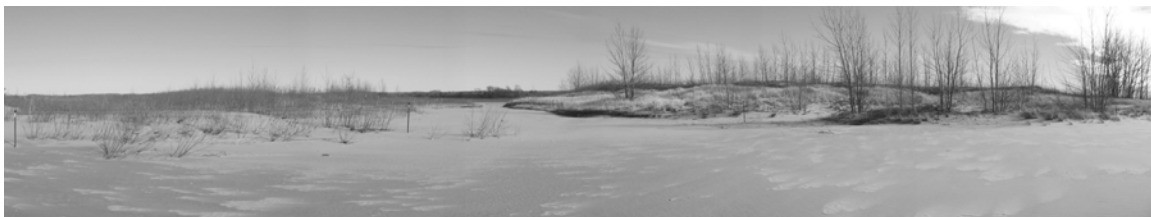
Figure 13 - Photomosaic of washover channel just south of Sandy Pond Inlet, view toward North Pond.

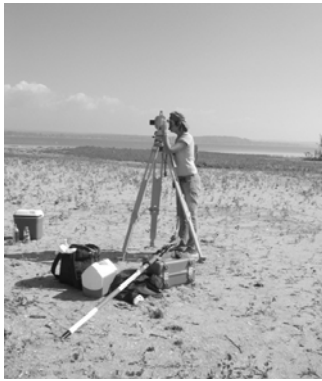
Figure 14 - EDM used to survey Sandy Pond Inlet

In order to study changes in bed topography, the inlet was mapped using an electronic distance meter (EDM or “total station”; Fig. 14) in July 2003 during high early-summer lake level, and at lower lake levels in September, 2003 and September 2004. A limited amount of dredging was done in late summer, 2004, before the September, 2004 map was made (E. Bernstein, pers. comm.). Survey data were loaded into Gocad™ drafting software and contoured. Figure 15 shows topographic maps made from the EDM surveys of the channel in July 2003, September 2003, and September 2004. It should be noted that few areas on land were surveyed, so the topography depicted in land areas is poorly constrained.

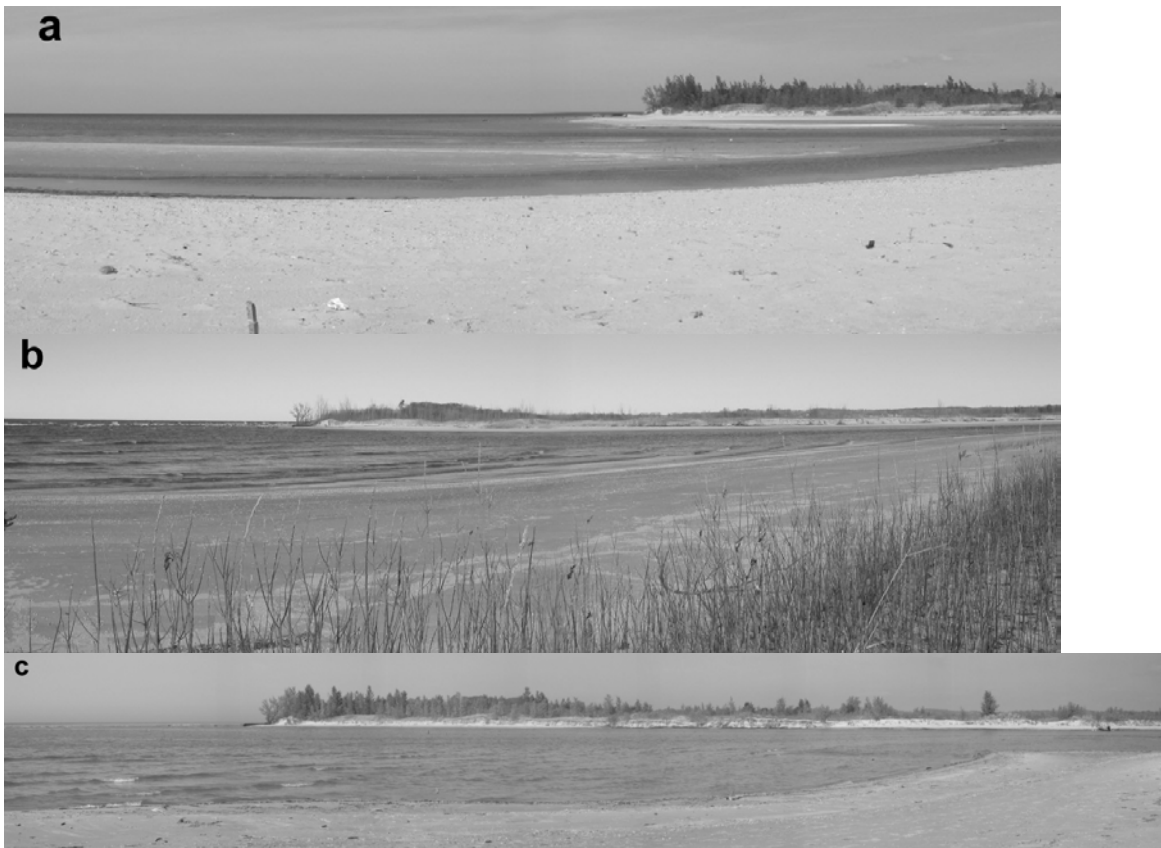
Figure 17 - Views of the transition zone of Sandy Pond Inlet in a) September, 2003, b) the day after the wind storm in November, 2003, and c) September, 2004. View to north.

The fall, 2003 wind storms caused many of the changes observed between September 2003 and September 2004. Photographs taken a day after the November 13-14, 2003 wind storm show that the inlet mouth had widened compared to earlier in the year (Fig 18). Photographs taken from approximately the same location on the south shore of the inlet channel in July, 2003 and November, 2003 show that widening of the transition zone and shortening of the inlet channel occurred during Fall, 2003 (Fig. 17). Modifications of the channel shoreline did occur between November, 2003 and September 2003, and it is not possible from photographs to determine the extent of deposition and erosion due to the storms. A local resident indicated that there was significant storm surge on North Pond during the October, 2003 wind storm (T. Jones, pers. comm.). Wave ripples were observed in the washover channel the day after the November, 2003 windstorm, indicating that water levels had been quite high during that storm as well.
