Avulsion by Chautauqua Creek

INTRODUCTION

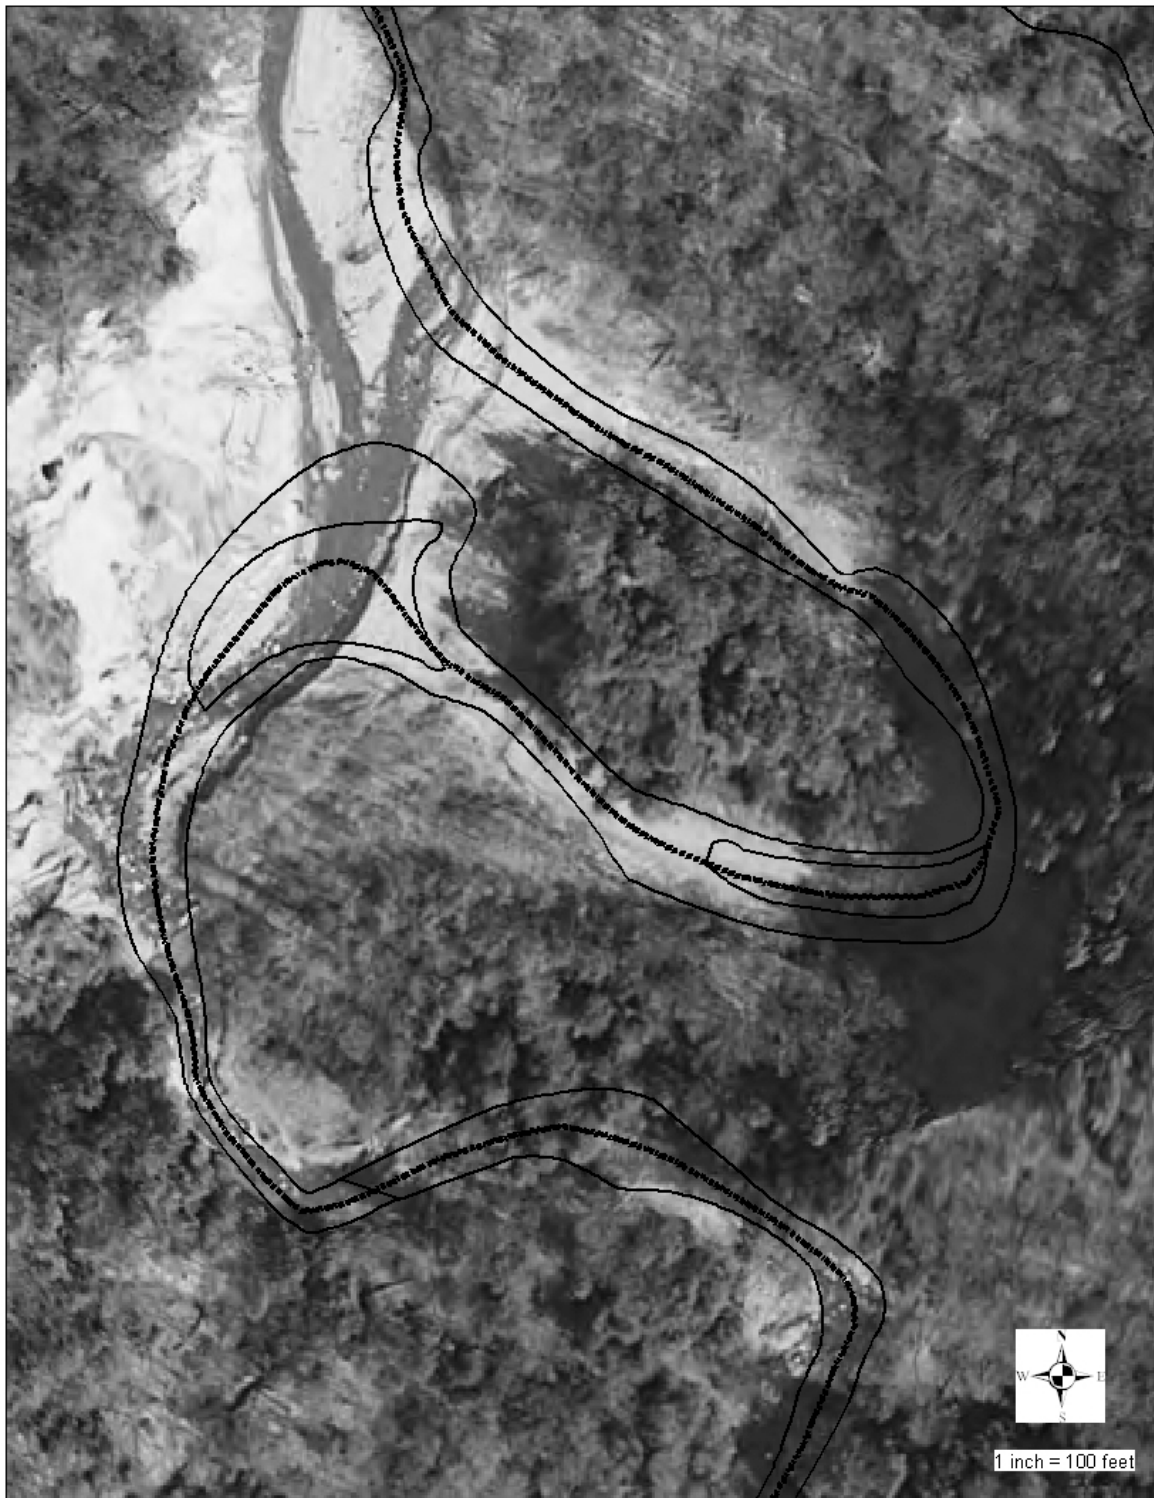
Figure 3: Post-avulsion aerial photograph taken in 2008. The position of the center line of the creek in 1954 is shown with a single heavy dashed line. The position of the creek in 2000 is shown with thin continuous lines that depict the approximate water channel. (Source: Chautauqua County GIS)

Figures 2 and 3 show the historic positions of the meander loops at Stop 2 (the undeformed sediments at Stop 1 are exposed by a combination of natural gully growth and reservoir outlet erosion). From the dates it can be seen that the stream alternates periods of erosion between the two faces of the meander loop, which led to the avulsion of the deposit in 2005.

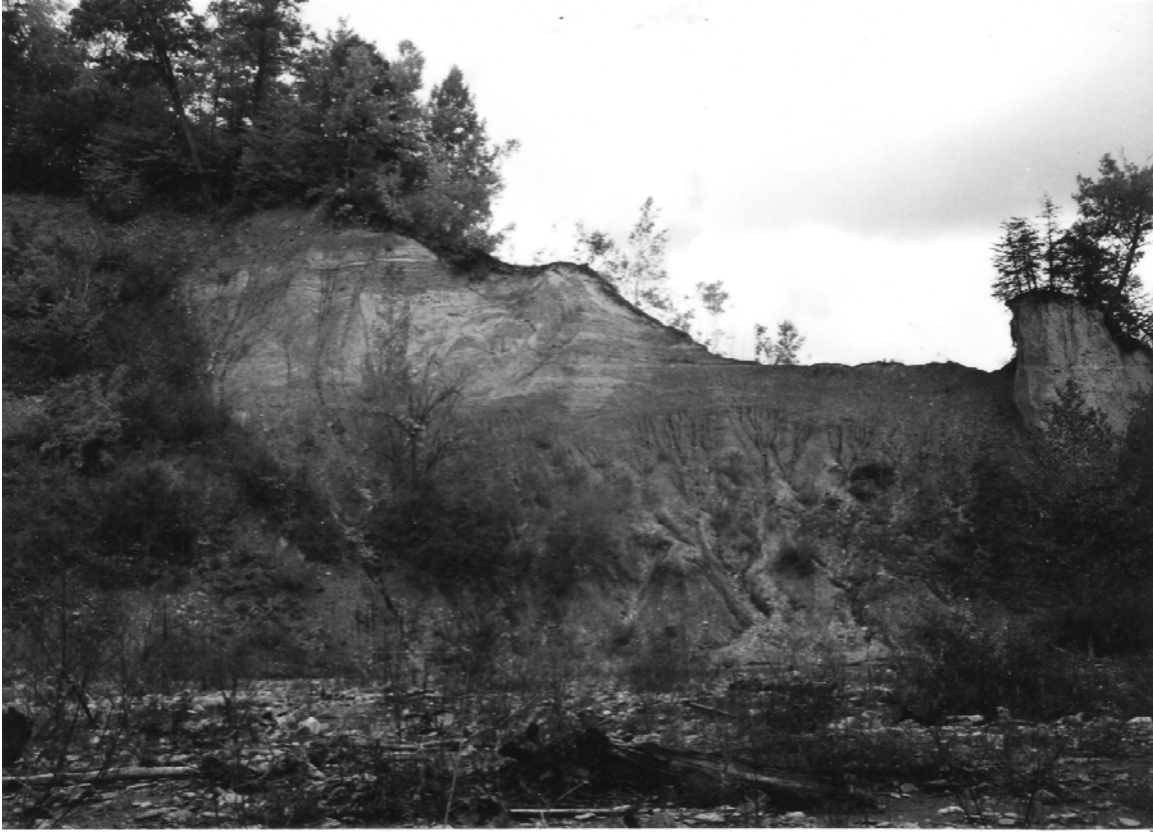
Figure 5: 1988 photograph of the south face

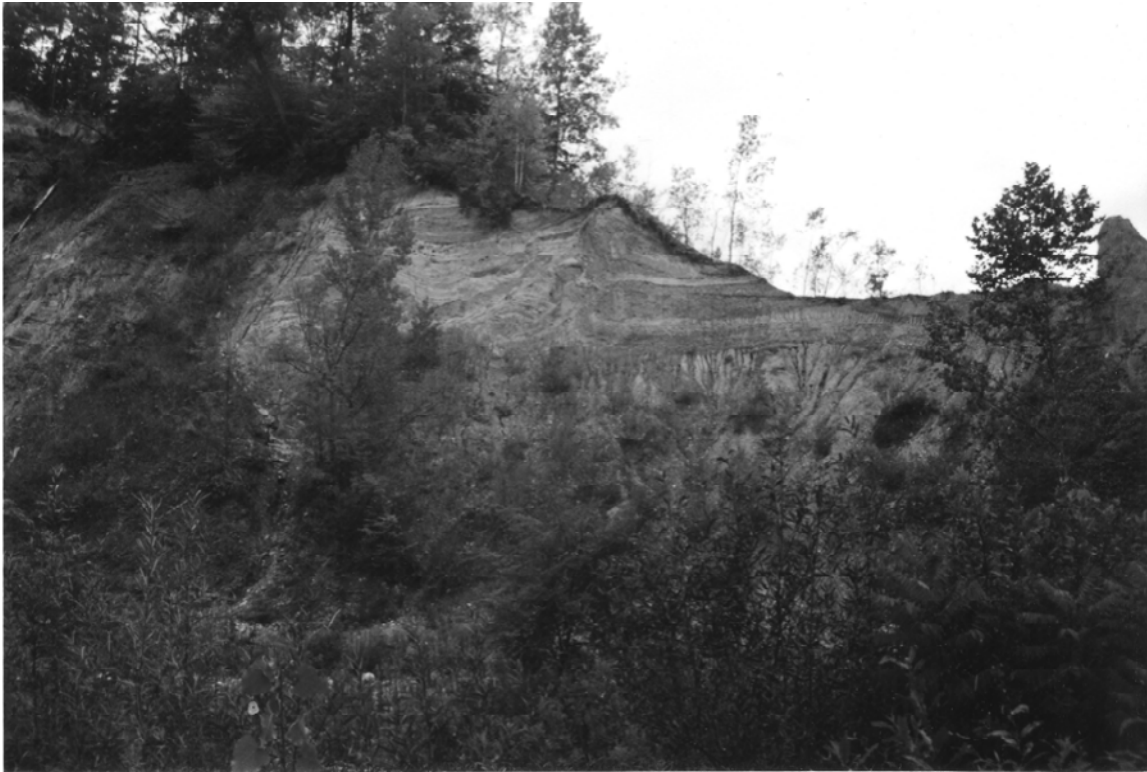
Figure 6: 1993 photograph of the south face. Note lack of vegetation on right side of photo compared to 1988
