Economic Geology of the Central Hudson Valley, New York

Paul H. Griggs¹ and Jeffrey T. Lang²

¹*Mining Geologist, Griggs-Lang Consulting Geologists, Inc. Troy, New York 12180, pgriggs@griggs-lang.com*

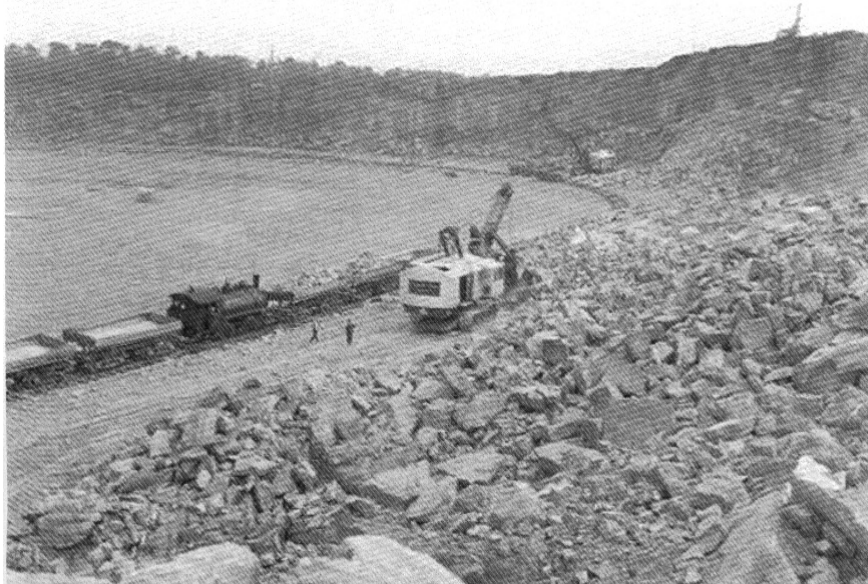
Figure 2. Electric shovel loading rail cars on the floor of the Universal Atlas Greenport Quarry in 1936.

Until the 1950's, Universal Atlas operated rail cars on an ever shifting series of rail lines to move stone from the quarry to the plant. The rail cars were loaded by electric shovels and hundreds of workers were employed handling electrical cable and moving the rail lines as the quarry faces advanced (see Figures 2 to 6).

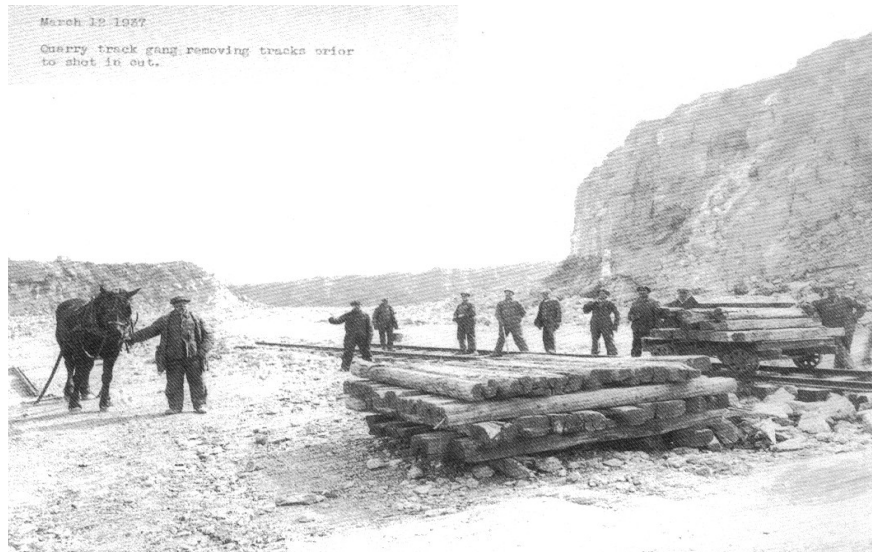
Figure 4. Moving railroad track at Universal Atlas Greenport Quarry in 1937.

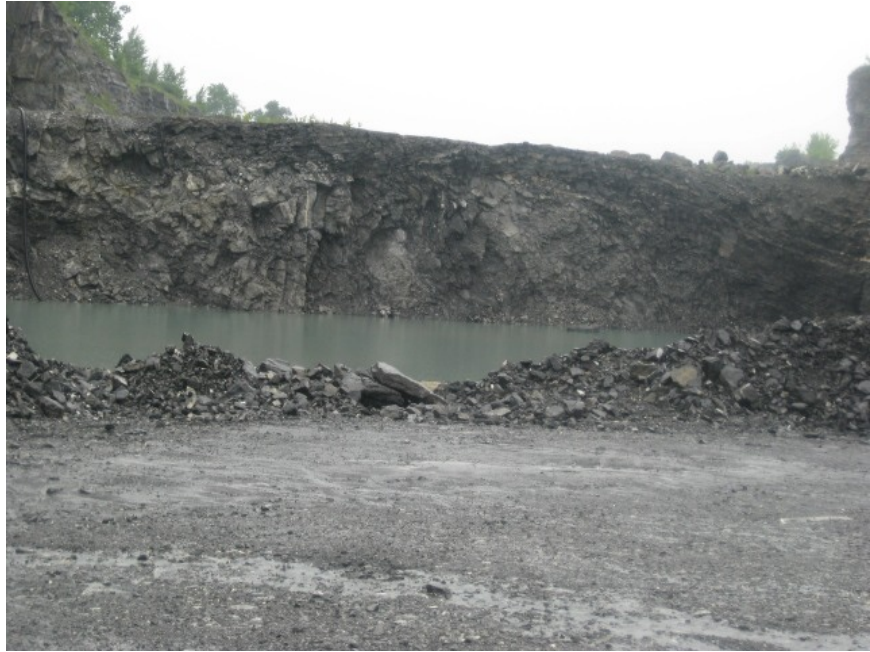
Figure 11. Photo of the north face of Mower's Lake showing the complex folding and thrust-faulting typical of this quarry. The dark colored rock at the upper right of the face is from the lowest part of the New Scotland Formation. It occurs in a sheet that has been thrust over a complex mélangé of Port Ewen-Alsen-Becraft.

A series of pumps discharge water from the quarry so that it can be worked dry. The water is used in the cement plant for thermal cooling. Overall, the structure in this area consists of a southward-plunging asymmetrical, heavily faulted syncline-anticline pair.

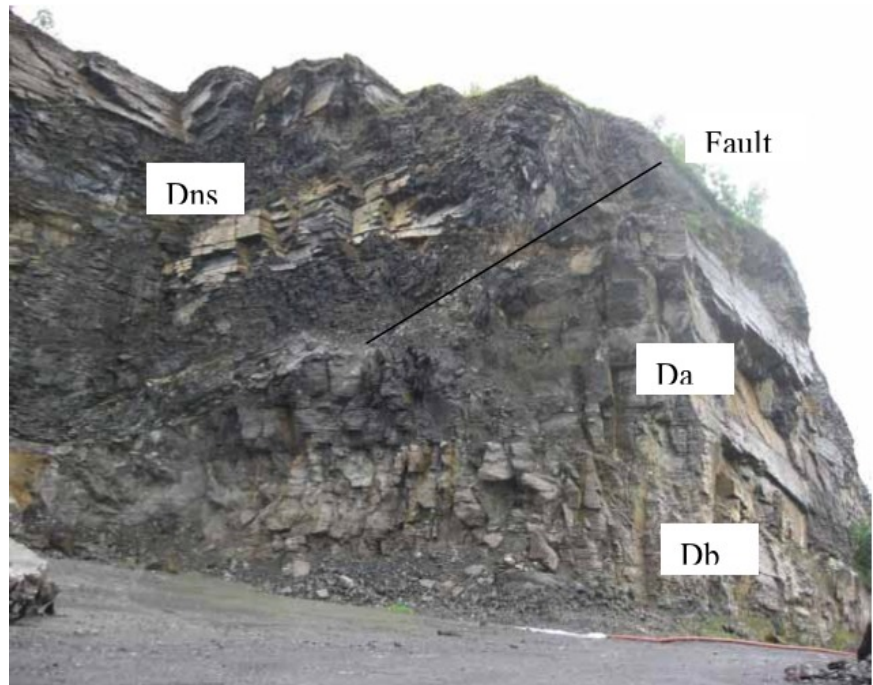
Figure 12. Photo looking south-southeast showing the general expression of Sucke's Fault in the east wall of the Apple Orchard.

Overall, the structure in this quarry consists of an asymmetrical, doubly plunging, rolling, highly faulted anticline-syncline pair. The west limb is nearly vertical and the east limb is bounded by the most prominent fault in the quarry, the Sucke’s Bluff (or “Sucke’s”) Fault. This fault has been traced the entire length of the quarry and onto the Lehigh Northeast Cement quarry to the south. The dark colored stone to the left (east) is New Scotland argillaceous limestone and the stone underlying the fault is mainly Alsen and Becraft limestone.

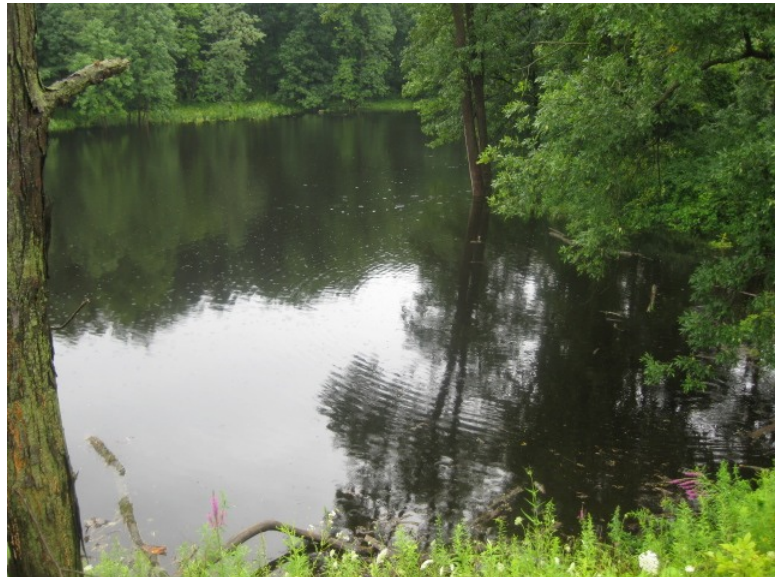
Figure 14. Photo looking northwesterly of the pond backed up behind the Streekie Lake sinkhole which is located in the lower right portion of the photo.

covered Devonian shales and a large drainage basin feeds to a sinkhole just west of this quarry. During dry weather, the sinkhole may be dry or is surrounded by a small pond a few feet across. This pond grows dramatically during wet weather (see Figure 14).

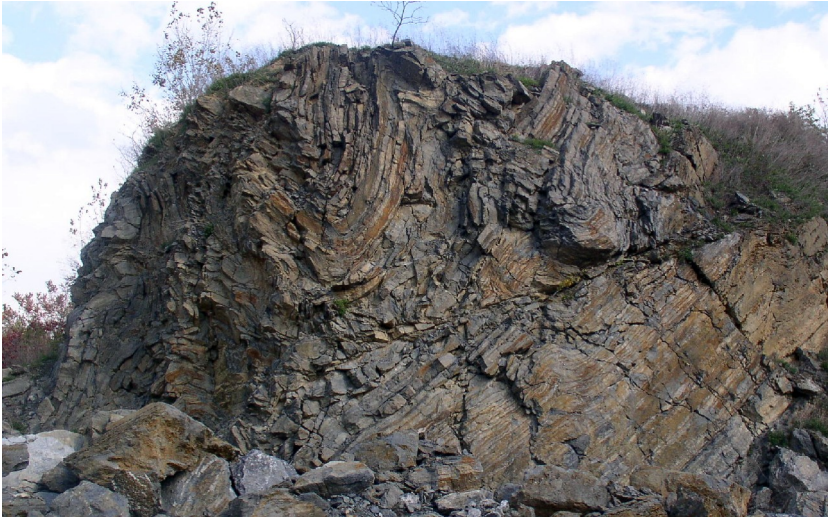
Figure 15. Photo looking northerly of chevron folding in Sucke’s Fault in the Ace in the Hole Quarry.

This quarry consists of a highly faulted, westward dipping west limb of an anticline primarily containing repeated sections of New Scotland and Kalkberg argillaceous and siliceous limestone. Holcim US has removed Coeymans and Manlius Limestone from the east wall. The west side of this quarry is bounded by Sucke's Fault (see Figure 15).

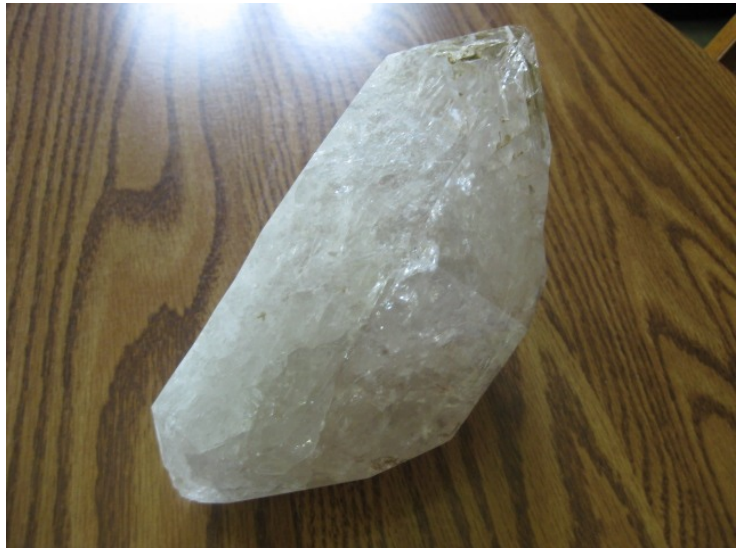
Figure 16. Photo showing doubly-terminated quartz crystal (“Catskill” diamond) found in Sucke’s Fault. The crystal is approximately 11 inches long.

The north-south trending Sucke's Fault typically dips to the west at about 60 to 80 degrees. However, the fault plane tends to wander at times and varies from slightly overturned to as low as 20 degrees. The two sides of the fault tend to widen in areas where the fault begins to rotate and larger fault slivers are common. The fault acts as a barrier to east-west flow of water and locally promotes north-south flow. Large doubly-terminated, internally flawed quartz crystals (nicknamed "Catskill" diamonds) are periodically found near this fault (see Figure 16).

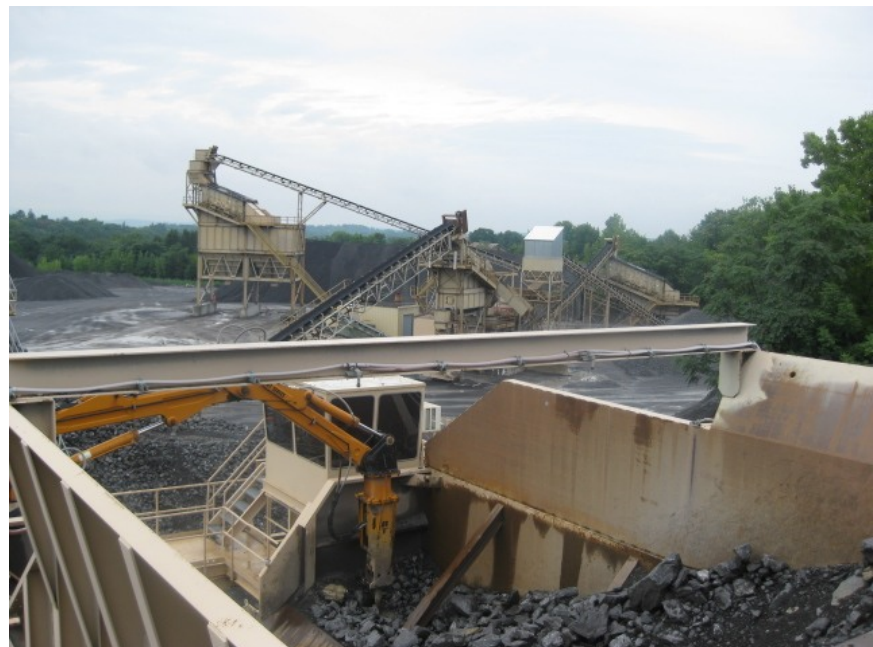
Figure 19. Photo showing feed hopper of primary crusher at aggregate processing plant at the Colarusso quarry on Becraft Mountain.

Construction aggregates are mechanically processed by a combination of crushers (primary, secondary and, often, tertiary), screens and conveyor systems. These mechanisms serve to reduce, separate and stockpile rock materials that have previously been removed from the quarry by blasting.

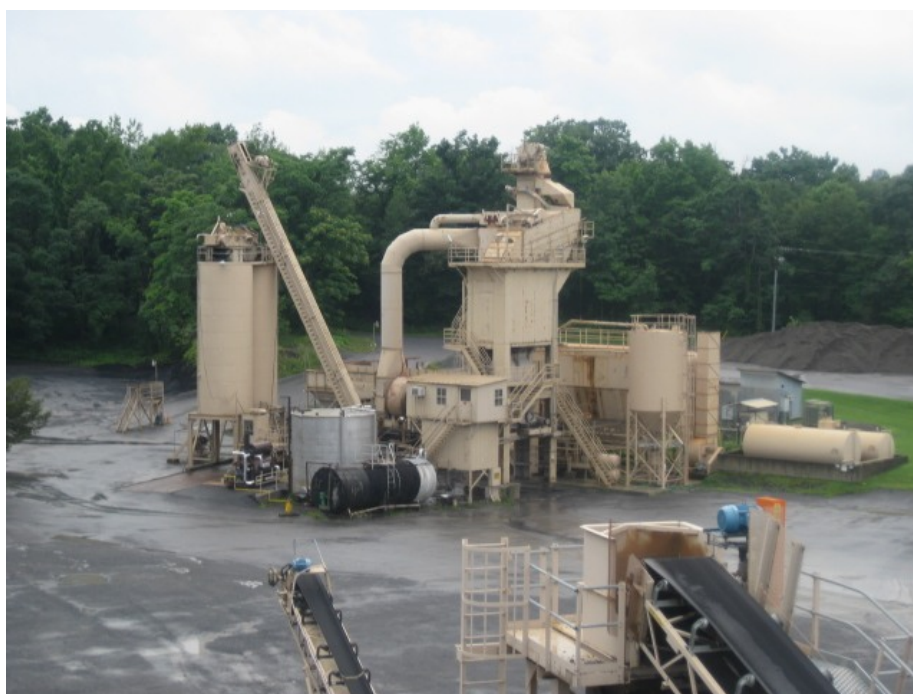
Figure 20. Photo showing blacktop plant at Colarusso quarry on Becraft Mountain.

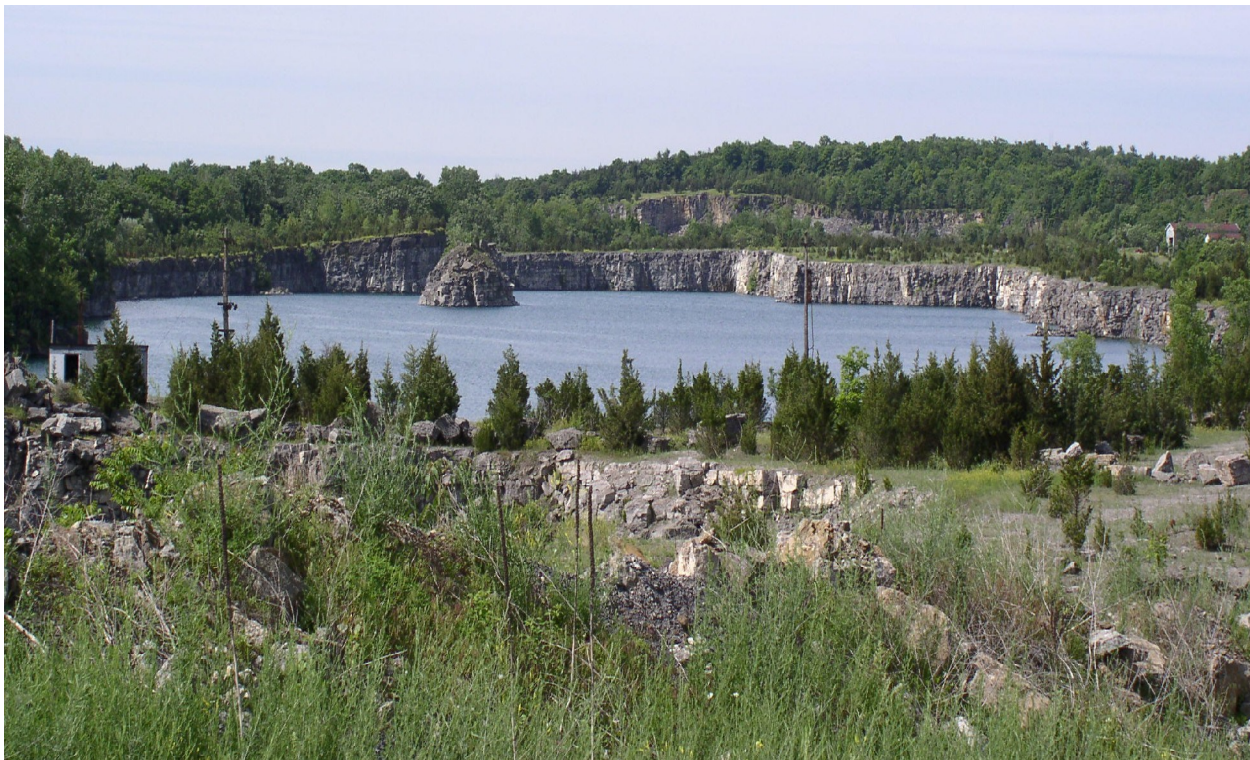
Figure 23. Photo showing water-filled (mine impoundment) at the Greenport Quarry. The excavated rock from the mined area in this photo was used largely for cement stone manufacturing.

cavation for cement stone (Becraft and Becraft contact) was limited from advancing to the full width of the first cut owing to the easterly dip of the western flank of the syncline. This resulted in a pinching out of the cement stone (Becraft and Becraft Contact) to the west. Mining by Universal Atlas ceased in 1976 and the excavated drop-cut slowly filled with water.

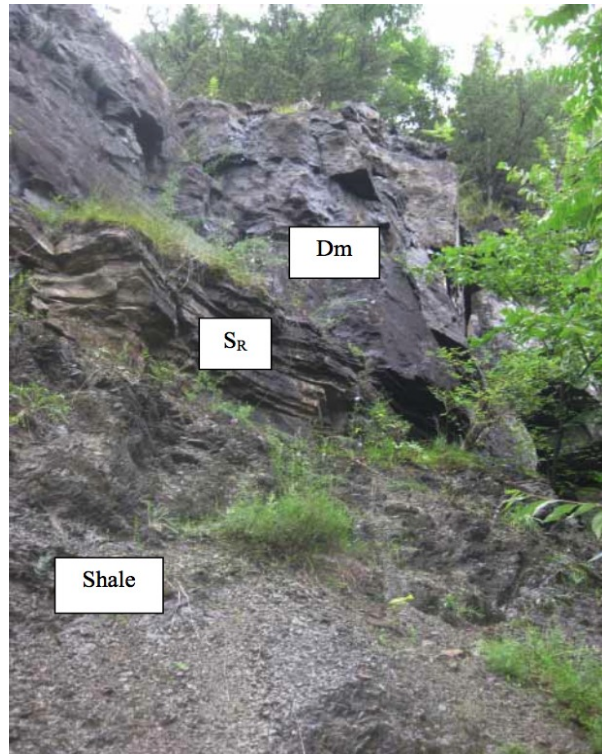
Figure 25. Photo of showing angular unconformity between the Ordovician shale and the overlying Silurian Rondout Formation.

STOP 12. Angular Unconformity and Old West Quarry. The angular unconformity (Taconic Orogeny) between the Ordovician shales and the overlying Silurian Rondout Formation is evident on the west side of Becraft Mountain in an outcrop south of the old West Quarry. The West Quarry was mined for cement stone (Manlius Formation) during the early and middle parts of the past century.

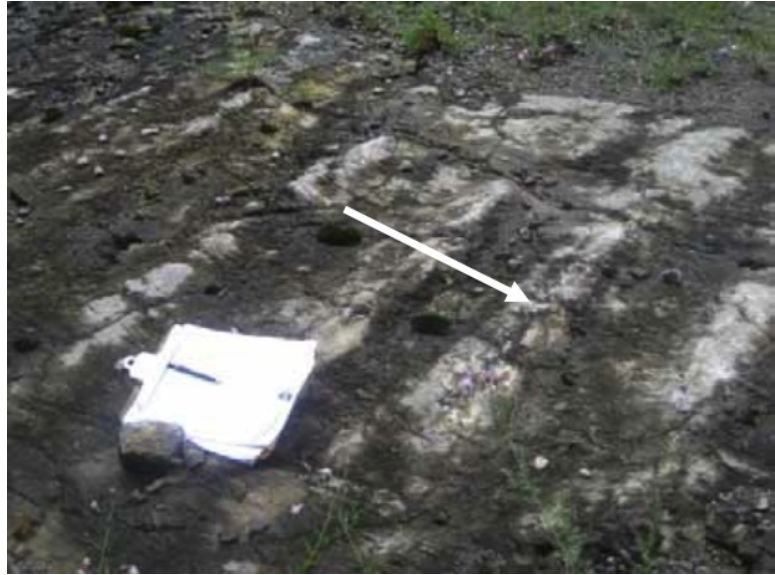
Figure 26. Photo of ripple marks in Manlius Formation on floor of West Quarry. Arrow shows inferred flow direction.

The *Manlius Formation* was deposited in slightly deeper water than the Rondout. The Manlius sediments were deposited in very shallow, generally quiet, somewhat saline (lagoonal) water and lithified into typically fine-grained, uniformly bedded limestones. Small reefs called biostromes occur scattered throughout the Manlius. The reefy parts of the Manlius were deposited in shallow, clear, agitated waters and typically consist of medium-grained, irregularly bedded limestones. Ripple marks in the Manlius Formation are evident on the sloping floor of the West quarry (see Figure 26).

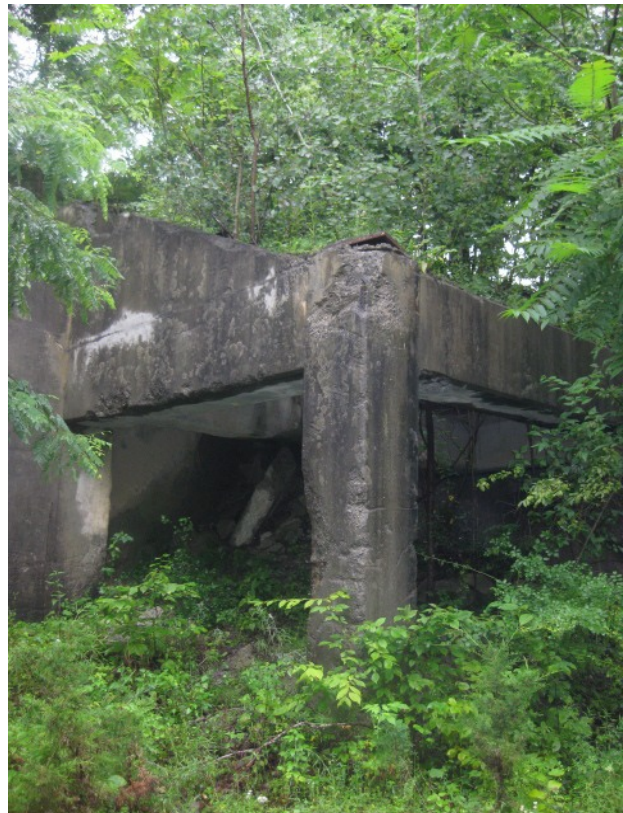
Figure 27. Photo of concrete foundation (c. 1937) of crusher used to reduce cement stone for use at Universal Atlas' cement plant in Greenport, New York.

Cement stone was crushed on site and transported by train and trestle over U.S. Route 9 to the Universal Atlas Cement Plant (see Figure 6). The railroad grade and crusher foundation is still evident in the area west of the notch (see Figure 27).

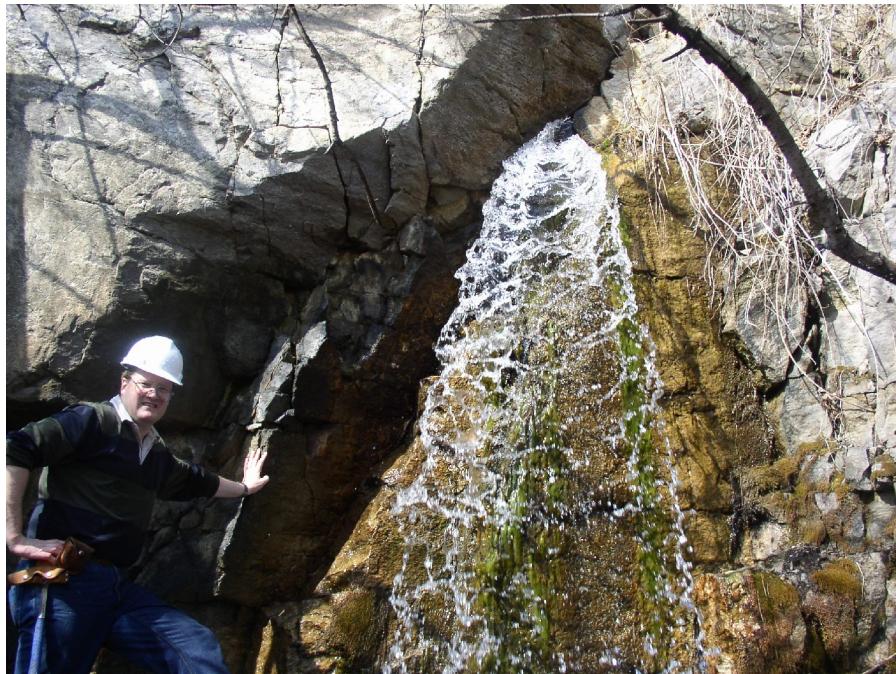
Figure 28. Photo of water-producing discontinuity in quarry wall. Flow is estimated at approximately 200 gpm.

Walls and floors of quarries excavated below the water table will only yield groundwater as fast as the host rock permits. Accurate mapping of joints (see Figure 28) and other discontinuities, in relation to the position of recharge areas (and the mine impoundment), is of critical importance, as are the hydraulic conductivities of the excavated units. Hydraulic conductivities can be estimated via pump tests, slug tests, packer tests and flow net construction, combined with proper geologic interpretation.
