Fluvial Geomorphology of the Upper Esopus Creek Watershed and Implications for Stream Management

Dan Davis¹, Peter L.K. Knuepfer², Nicolas Miller³ and Mark Vian¹

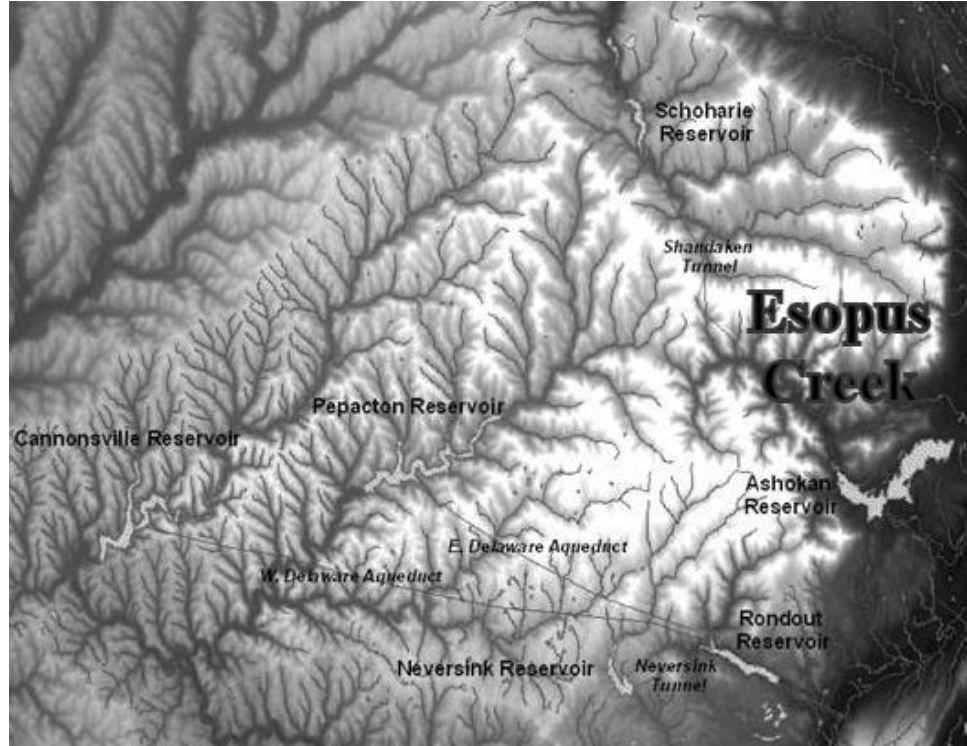
Figure 1. DEM of Catskill watersheds of the New York City water supply system. From Czekanski, 2005.

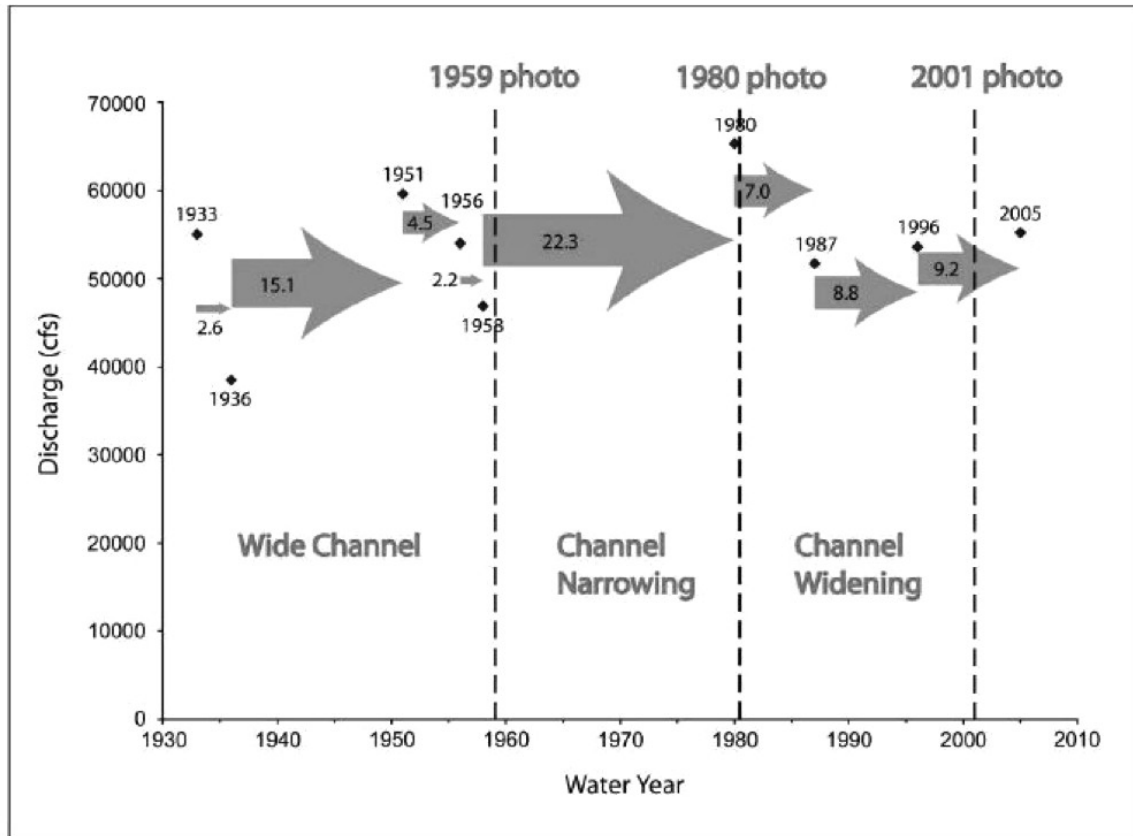
Figure 7. Intervals between large discharge events at Coldbrook gage and interpreted stream response. Note that bank erosion appears to occur mostly during intervals of frequent large flows. From Miller (2009).

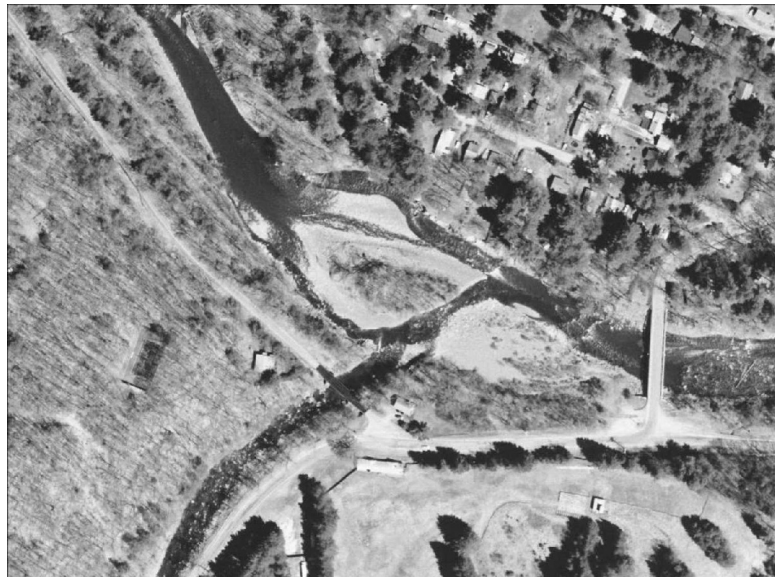
Figure 10. Aerial photo of the Woodland Creek/Esopus Creek confluence. The project reach extends from the head of the bifurcated reach down to the Woodland bridge (2001, DOQQ)

included increasing potential for exhuming several residential septic systems, causing additional property damage, producing a continuing source of turbidity and creating a hazard to recreational users of the stream (Figures 10 and 11).

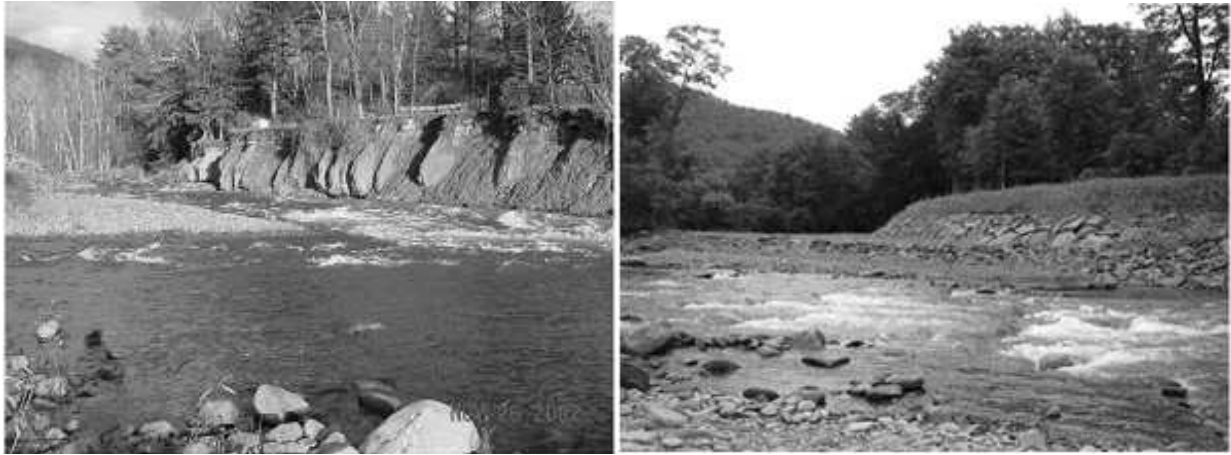
Figure 11. Esopus Creek at Woodward Valley restoration site before (left) and after (right) restoration project. Post-project photo taken July 13, 2004, approximately 9 months after construction, but before major flood in April 2005. From Barnet, 2004.

In 2000, DEP hired FIScH Engineering (principal engineer Dr. Craig Fischenich) to complete an assessment and conceptual design for remediating this reach (Fischenich, 2001). The hydraulic and stability analyses, sediment transport calculations, and geomorphic assessment resulted in recommendations for an approach that incorporated several technical techniques including a channel relocation based upon natural channel design principles, bioengineering and traditional bank revetment, and habitat and recreational enhancement features. DEP selected this project to be the demonstration stream restoration project for Esopus Creek required by the US EPA as part of the FAD schedule of compliance (US EPA, 2007). The project was constructed in 2003 in two stages: the channel work, bank revetment, and flood plain reconstruction were completed by Oct. 1, 2003 and the vegetation (trees and willow fascines) and bioengineering (VRSS) were completed in early Dec., 2003. Figure 12 is an aerial view of the site taken approximately one year after construction (Aug., 2004).

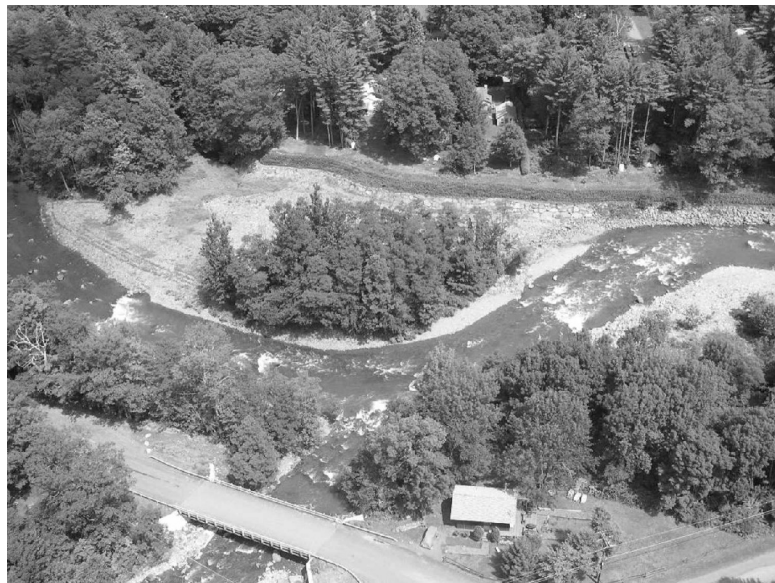
Figure 12. Esopus Creek Restoration Demonstration Project - one year after completion (August, 2004).

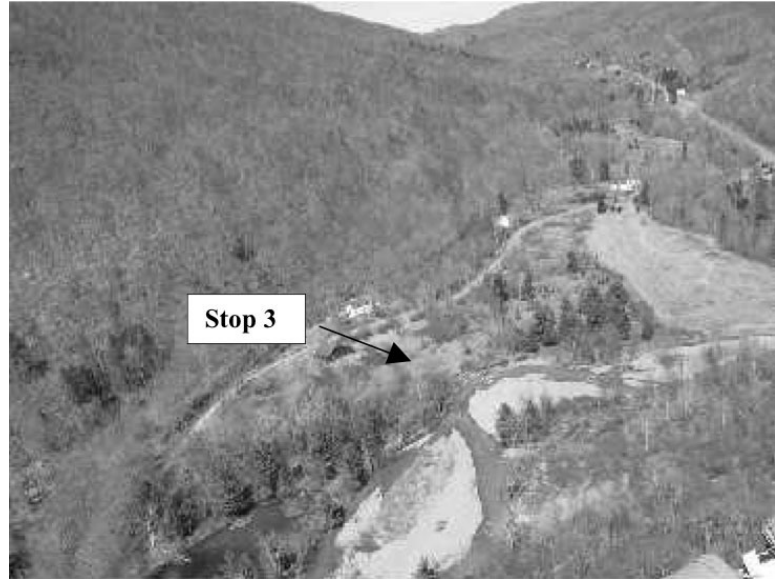
Figure 14. Aerial view of meander bend along Esopus Creek undergoing failure at Stop 3. Photo taken April 10, 2005. From NYC DEP et al., 2007.

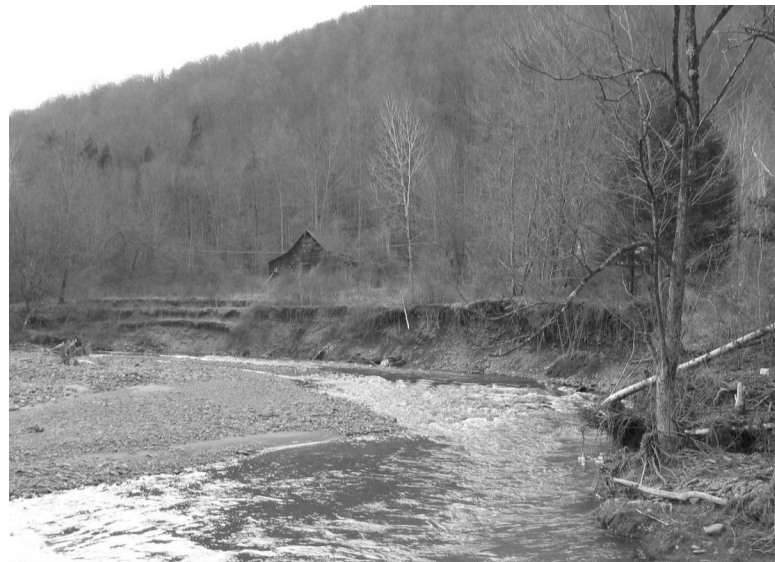
Figure 15. View upstream toward actively retreating streambank with rotational failure scarps exposed in adjacent terrace (photo courtesy DEP, 2006).

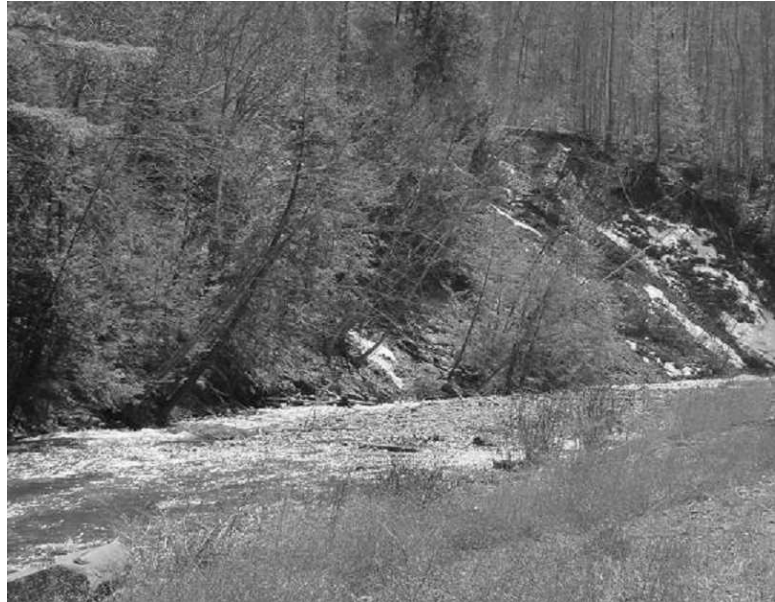
Figure 18. Pre-restoration landsliding along right bank of Stony Clove at Lanesville site. Photo from DuBois, 2003.

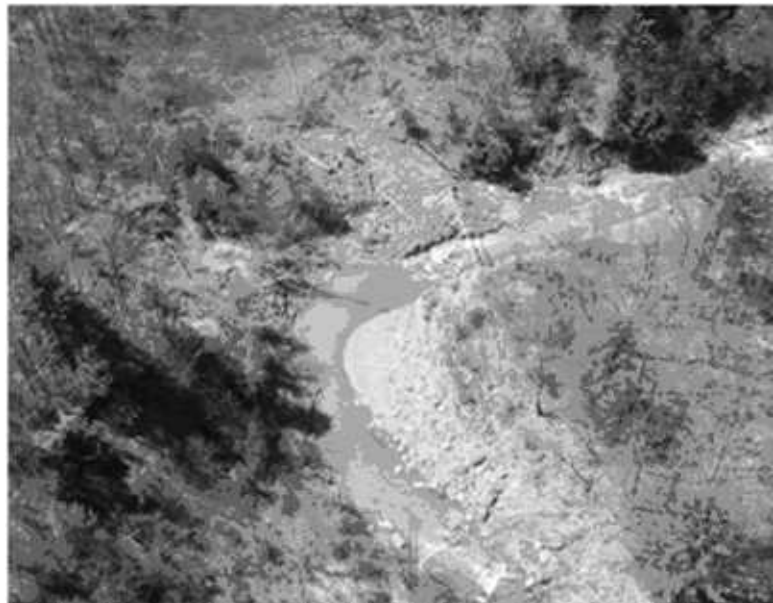
Figure 20. Landslide along Stony Clove upstream of Chichester Post Office. Photo from NYCDEP et al., 2007.

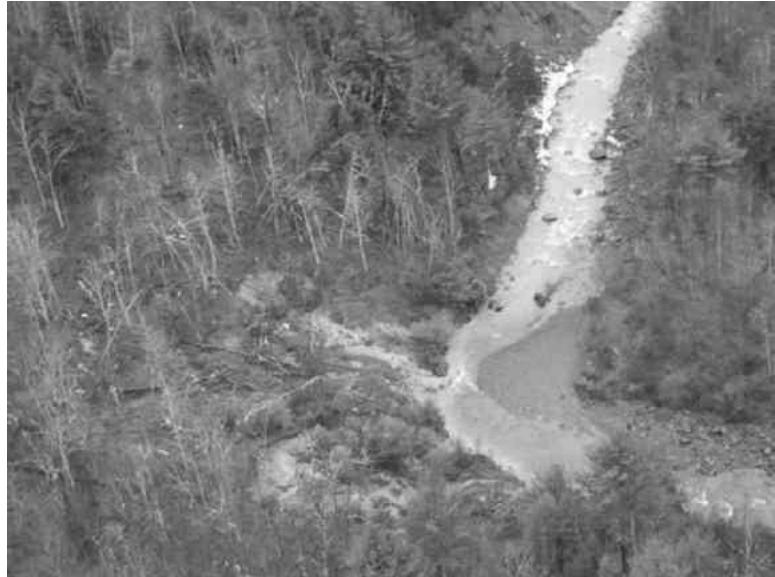
Figure 21. Downstream-looking view of suspended sediment from landslides entering Stony Clove Creek and increasing downstream turbidity. Photo by Dan Davis, DEP, March 19, 2009.

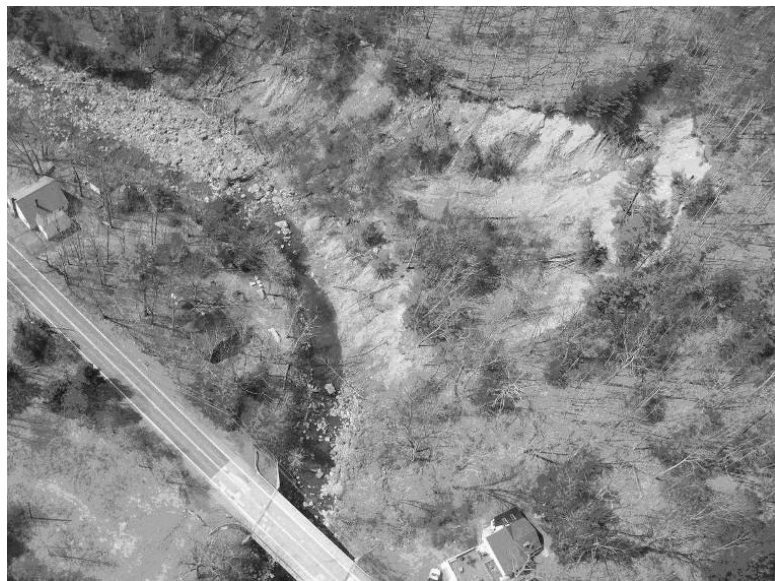
Figure 22. Landslide along Beaver Kill. Stop BK2 at bridge. Photo from NYCDEP et al., 2007.

STOP BK 2. LANDSLIDE IN GLACIAL DEPOSITS. (15 MINUTES) (Location UTM 18 T 561108E 4656095N) A landslide along the right bank of Beaver Kill has propagated as much as 70 m upslope and at least 70 m along the channel downstream of the Hwy. 212 bridge (Figure 22). This site is a dramatic representation of several similar stream bank erosion/hillslope mass failures in the confined portions of the Beaver Kill watershed that seem to be significant sources of bedload sediment supply resulting in numerous gravel/cobble bars that induce further lateral erosion of the channel. An assessment of this stream corridor is planned for late summer 2009.

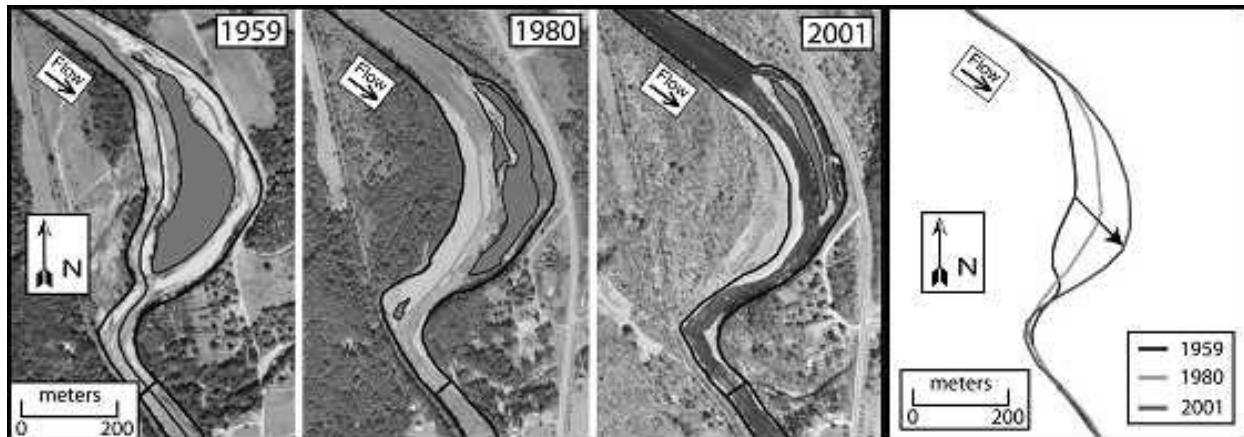
Figure 23. Changes in meander geometry at Beechford. From Miller, 2009.

STOP 8. MEANDER BEND MIGRATION ON ESOPUS CREEK AT BEECHFORD. (15 MINUTES) (Location UTM 18 T 560476E 4652445N) The meander of Esopus Creek just upstream of this location has been migrating eastward and downstream, as recognized from comparison of aerial photographs from 1959, 1980, and 2001 (Miller, 2009; Figure 23). The channel here appears to have been left (east) of the island on the 1903 topographic map. By 1959, the channel had avulsed to the right (west) side of the floodplain, though the original channel was still occupied (at least in part) as a secondary channel, creating a mid-channel island. We do not know exactly when this occurred, nor whether this was a natural avulsion or was induced to protect the Hwy. 28 alignment. However, the main channel has been migrating eastward since 1959, eroding the island and creating a point bar on the right (west) bank. This continuing meander migration likely will result in reoccupation of the original channel and could threaten the Hwy. 28 alignment in the future.
