*Hindcasting, forecasting, and controlling erosion at the
Western New York Nuclear Service Center*

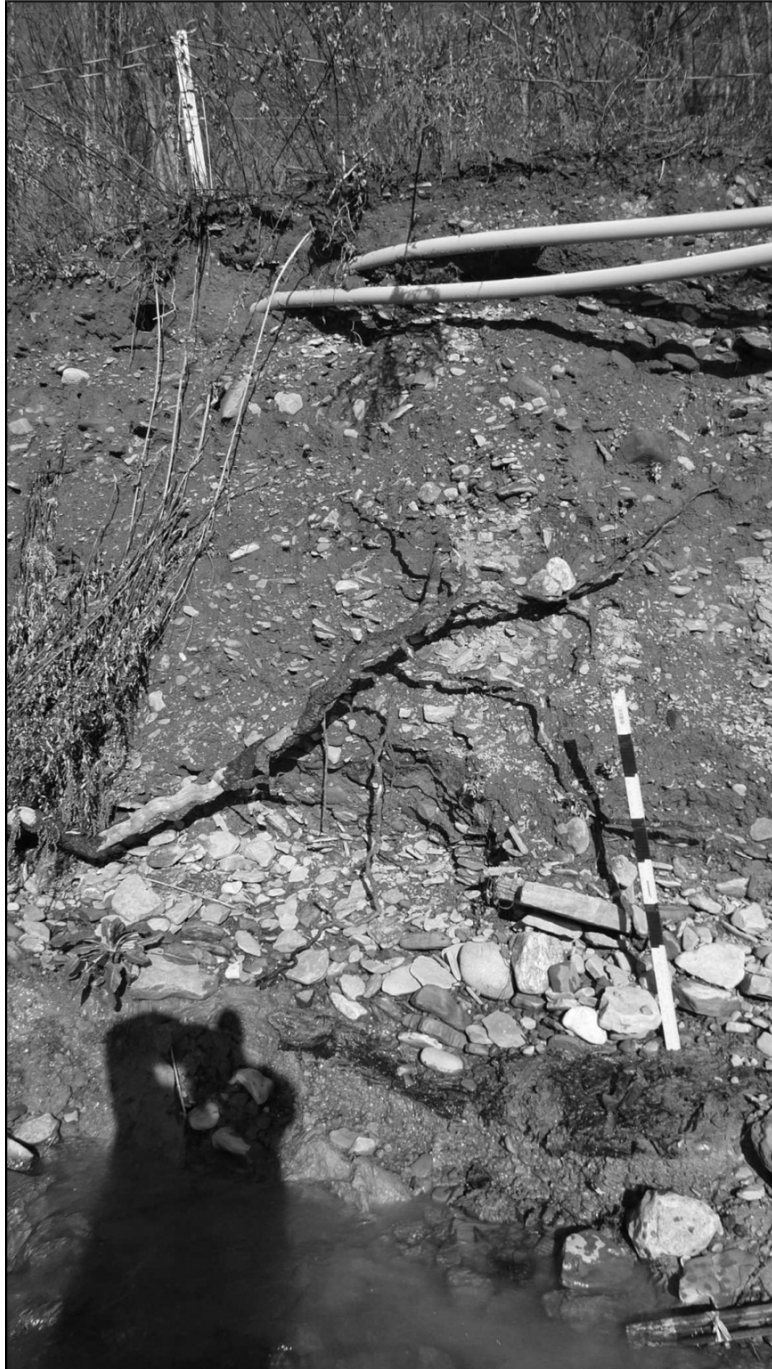
Figure 4 - Large wood sample at base of ~3m terrace at interface between Lavery till and fluvial cobbles. Wood sample dated to ~2,300 YBP. Sample in Connoisarauley Creek, which occupies the next watershed to the west of Buttermilk Creek.

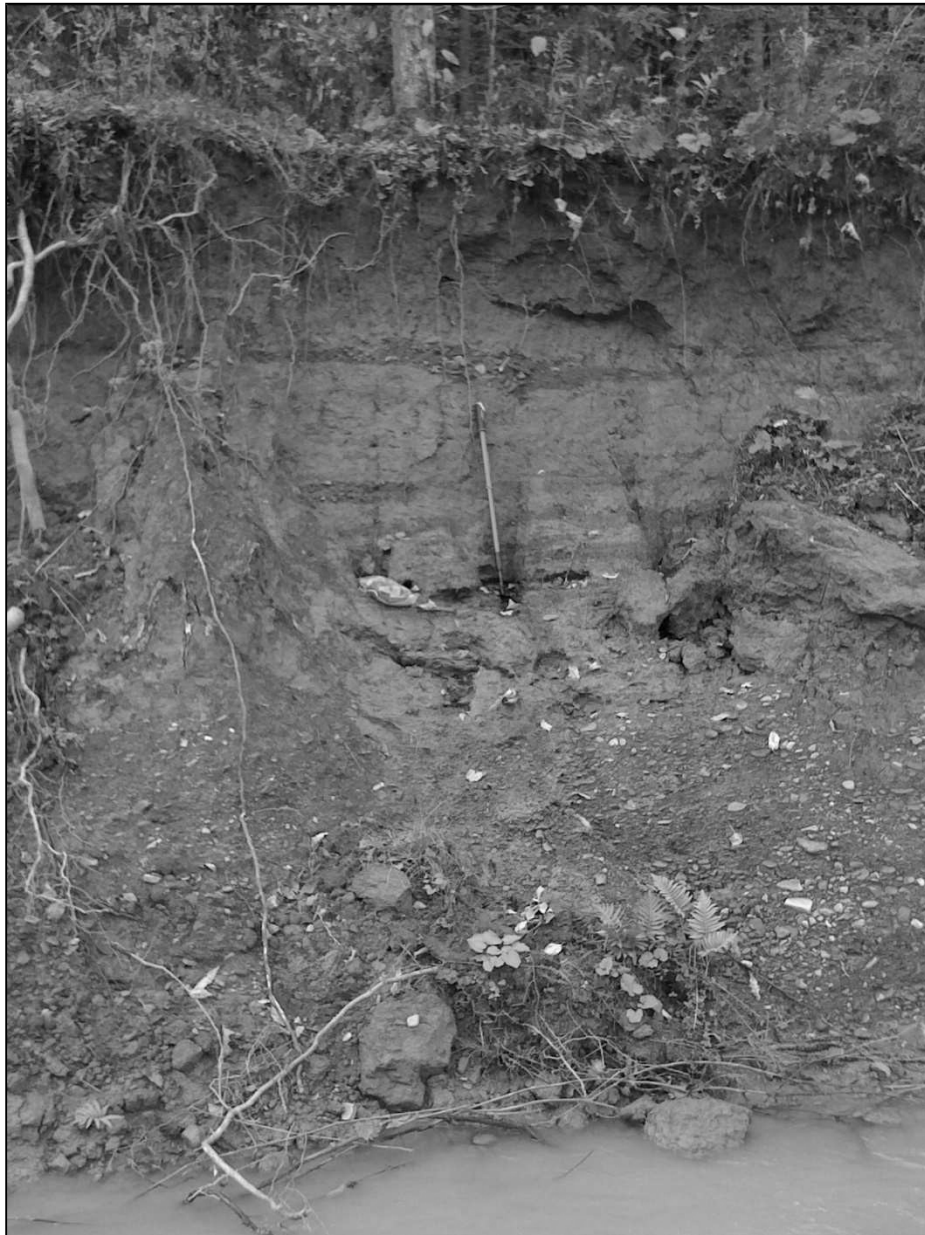
Figure 6 - "Valley-filling" fluvial terrace on Buttermilk Creek, a ~4.0m high aggradational feature. Intact livery till can be found at the base of the terrace. A wood sample excavated at the base of the red pole dates to ~520 YBP.

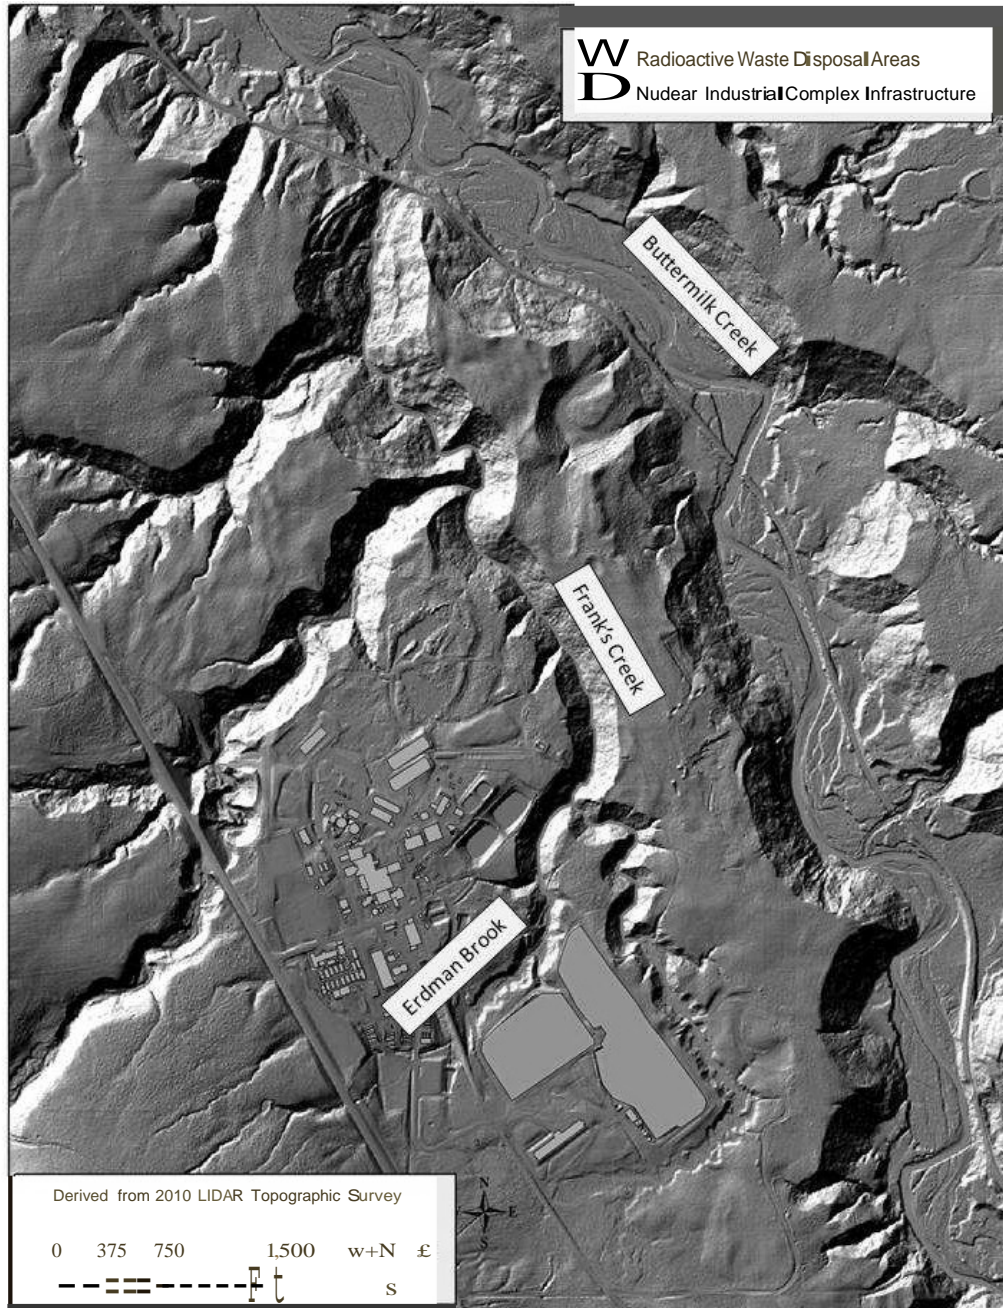
Figure 7 - Hillshade topography highlighting Buttermilk Creek and tributaries Frank's Creek and Erdman Brook and their proximity to the radioactive waste disposal areas and the infrastructure of the industrial complex

The large tributaries to Buttermilk Creek have dissected and incised the Lavery till plateau and generally occupy steep, deep V-shaped valleys lacking any floodplain. The discussion that follows focuses on the large Buttermilk Creek tributary known as Frank's Creek and its smaller tributary Erdman Brook (Figure 7). The convex longitudinal profile of Frank's Creek/Erdman Brook (Figure 8) is interpreted to mean that the system is inherently unstable and will continue to incise even if the baselevel at the confluence does not change. The instability is evidenced by the continued headward incision and dissection of the landscape, coupled with valley widening. The development and migration of knickpoints

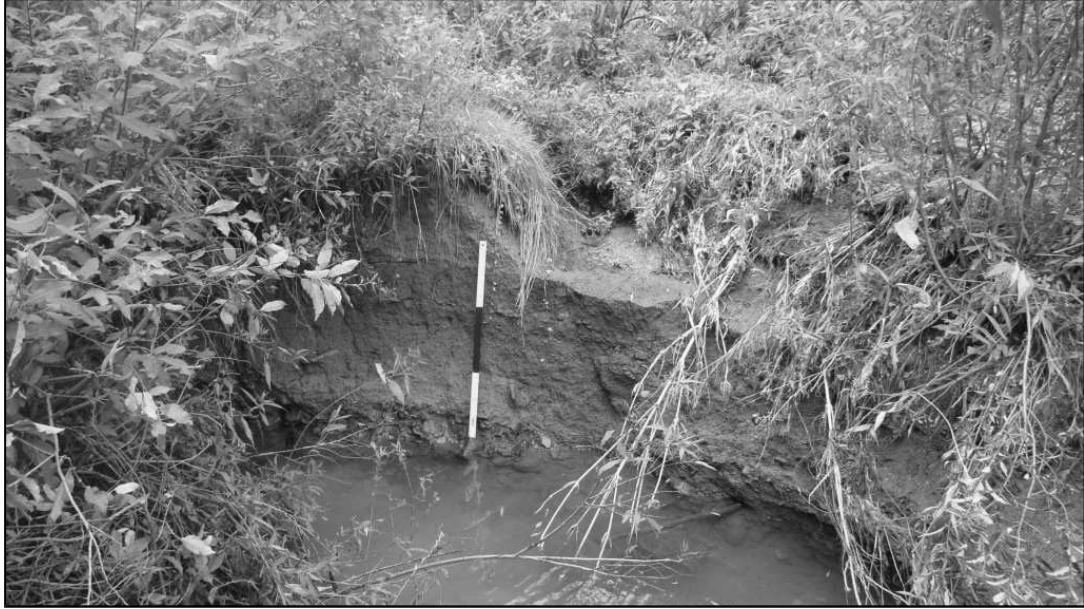
Figure 9 - Active knickpoint on Erdman Brook. Stained gravel layer at waterline marks interface between fine-grained fluvial deposits (above) and Lavery till (below). Exposed branch below waterline dates to ~400 YBP. Total knickpoint height is ~1.5m.

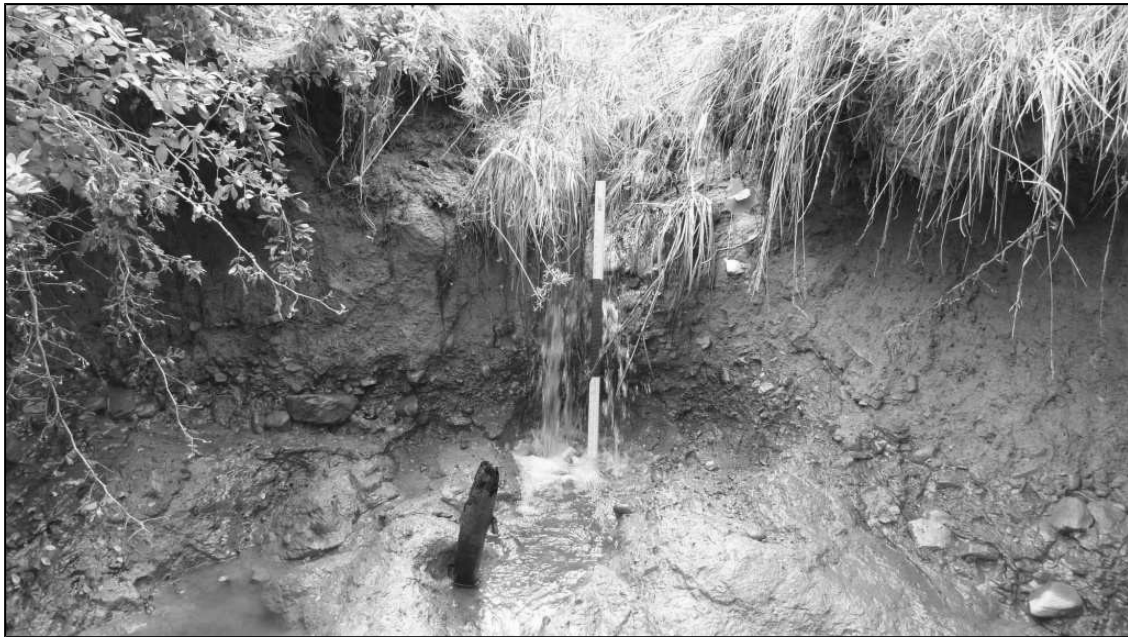
Figure 10 - Active knickpoint on Frank's Creek. Stained gravel layer marks interface between fine-grained fluvial deposits (above) and Lavery till (below). Exposed branch dates to ~180 YBP. Total knickpoint height is ~2.5m.

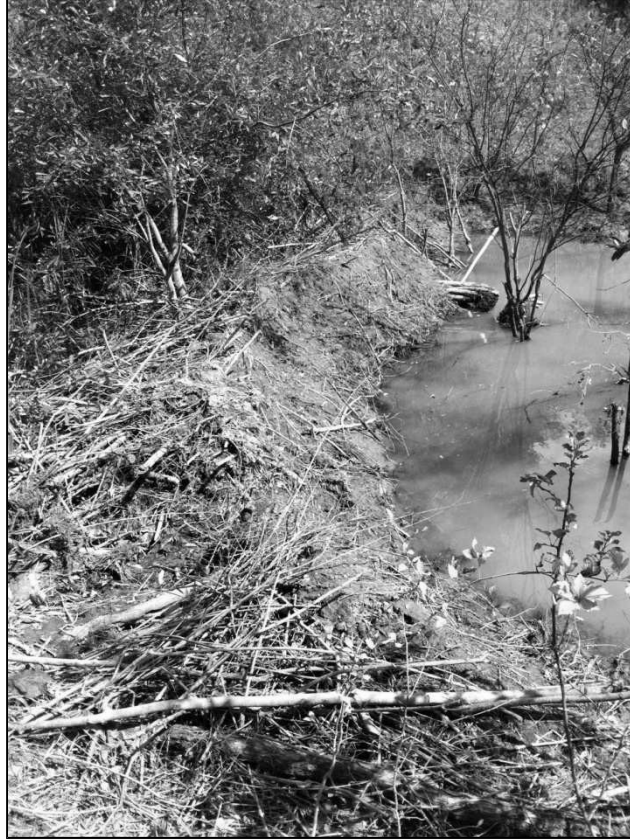
Figure 11 - Beaver dam constructed on Frank's Creek near the radioactive waste disposal areas.

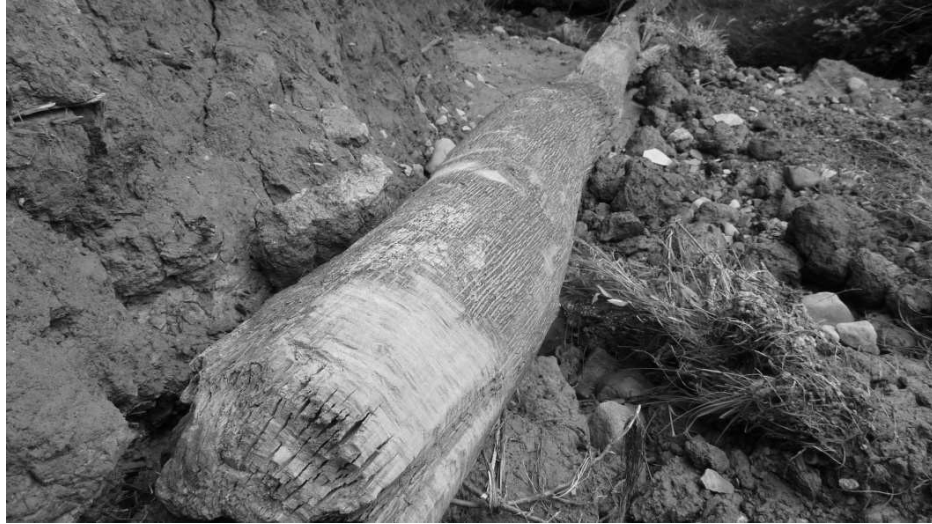
Figure 12 - Log exposed by migrating knickpoint in Frank's Creek shows evidence of having been felled by beavers. Log had been covered by approximately 2 meters of fine-grained deposits and was resting on intact Lavery till. Log dates to approximately 220 YBP.

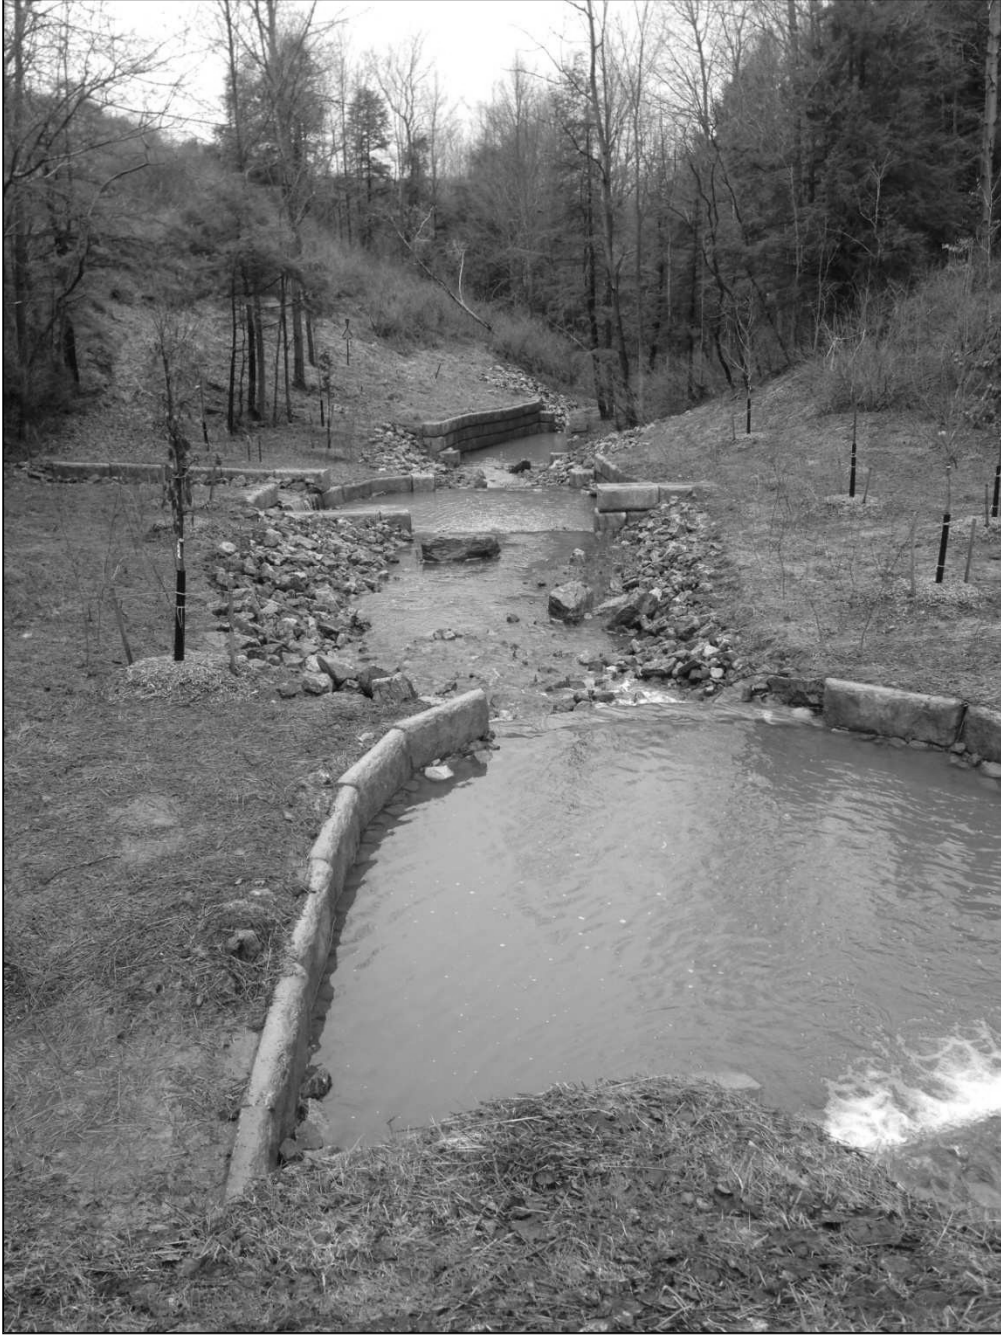
Figure 14 - Erosion Control Structures Installed on Erdman Brook. Shown are a series of pools and riffles. Looking downstream.

On both Erdman Brook and Frank's Creek a number of grade-control structures have been installed during 2009-2013. The structures are typically based on a pool-riffle design with incorporated anchored grade control (Trip Stops 2 and 3, Figures 13 and 14). At knickpoint brinkpoints, interlocking subsurface concrete block walls have been installed perpendicular to the stream valley and keyed into the Lavery till that underlies the more erodible surface deposits. These walls extend outward from the center of the valley to the extent of the 100-year floodplain. Immediately downstream of these grade-control walls, the knickpoint scour pools have been reshaped and armored, and designed to outflow into

Stop #2. Erdman Brook Erosion Controls: Grade control and armored pool-riffle sequences for mitigating knickpoint erosion. Installed 2009-2012.
