HEAVY METAL CONTAMINATION FROM ILLEGAL BURN PILES IN AN ECOLOGICALLY SENSITIVE SITE IN WEST HAVEN, VERMONT

Helen Mango¹, Department of Natural Sciences, Castleton University, Castleton, VT 05735
 Mary Droege², Department of Natural Sciences, Castleton University, Castleton, VT 05735
 J. Murray McHugh³, The Nature Conservancy, Southern Vermont Office, 348 Bentley Ave., Poultney, VT 05764
 Michele Hluchy⁴, Geology and Environmental Studies, Alfred University, Alfred, NY 14802
 Email addresses: helen.mango@castleton.edu, mary.droege@castleton.edu, mmchugh@tnc.org,
fhluchy@alfred.edu

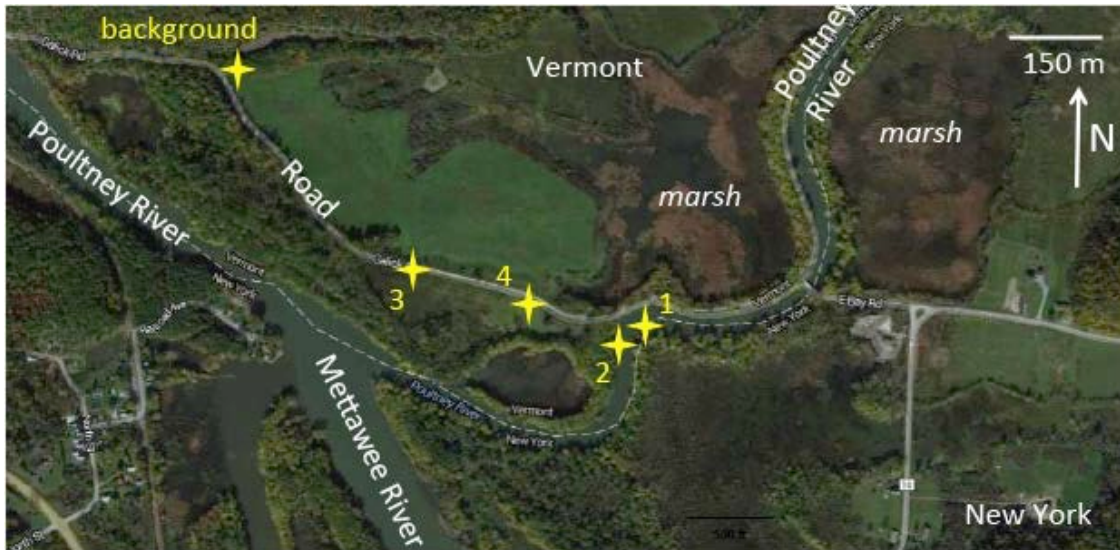
Between 2011 and 2017, burn piles at four different locations along Galick Road were sampled and the samples analyzed for a number of elements. Some burn pile sites were sampled multiple times over the years. The location of the burn piles, and the location where “background” samples were taken, are shown in Figure 2.

Figure 2. Location of different burn piles and background sampling site.

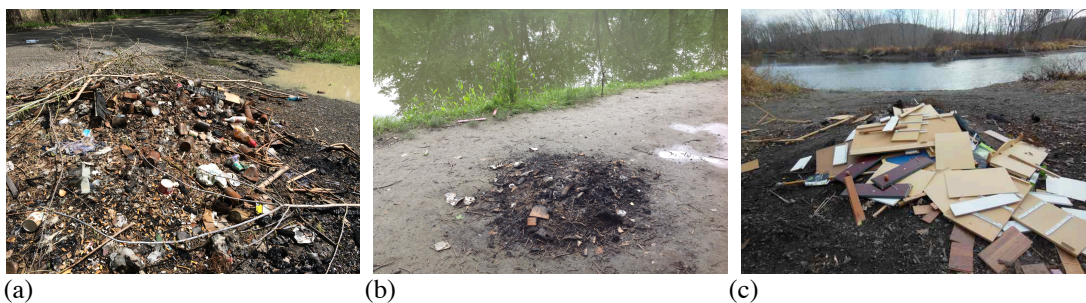
Figure 3 shows Burn Piles 1 and 2, photographed at different times.

Figure 3. (a) Burn Pile 1 in 2015. (b) Burn Pile 2 in 2014. (c) Burn Pile 1 in 2013.

Sampling and analysis of burn piles began with one grab sample of Burn Pile 1 in 2011. This pile appeared to undergo the most dumping and burning of all the burn piles over the years. Burn Pile 2 was closer to the water’s edge, and so was periodically flooded. Burn Piles 3 and 4 were located farther away from where people would congregate, and only appeared to be “active” in 2013. The materials dumped over the years included household trash (from diapers to batteries), junked furniture, construction debris, and commercial waste. There was also refuse related to the bonfires, predominantly beer cans. Table 1 lists the items found over the years of sampling.

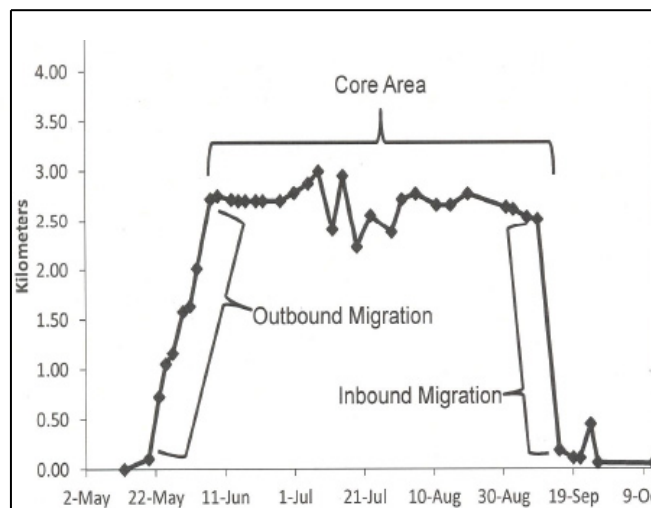
The movement of one radio telemetered male timber rattlesnake during one season is shown in Figure 8 as a time-series graph. The “outbound migration” consists of a series of long, rapid movements away from the hibernaculum in the spring. The “core area” consists of a period of slower, shorter movements at a relatively stable distance from the hibernaculum during the summer. The “inbound migration” repeats the long, rapid movements back towards the hibernaculum in the fall.

Figure 8. Displacement as a time-series graph for a typical radio-telemetered male rattlesnake.

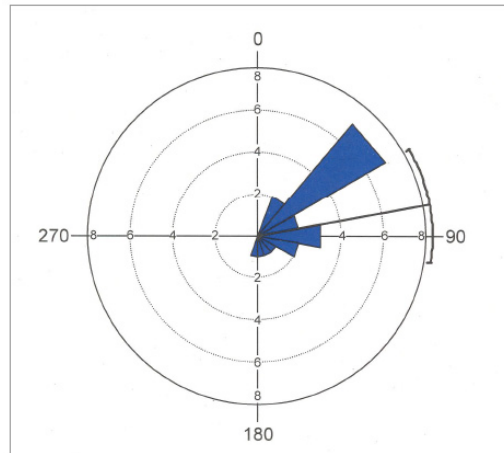
Most snakes migrated northeast from their hibernacula (Figure 9), spending the summer on private land (which is not protected).

Figure 9. Rose diagram showing the mean bearing of outbound migration for 22 rattlesnakes monitored with radio telemetry in 2011 and 2012.
