Trip B-2

EASTERN LAKE ONTARIO DUNE-WETLAND COMPLEX FROM THE PLEISTOCENE TO TODAY: LAURENTIDE ICE SHEET DEGLACIATION, SHORELINE EVOLUTION AND MODERN GEOECOLOGY

ROY L. WIDRIG

New York Sea Grant, State University of New York at Oswego, Oswego, New York 13126

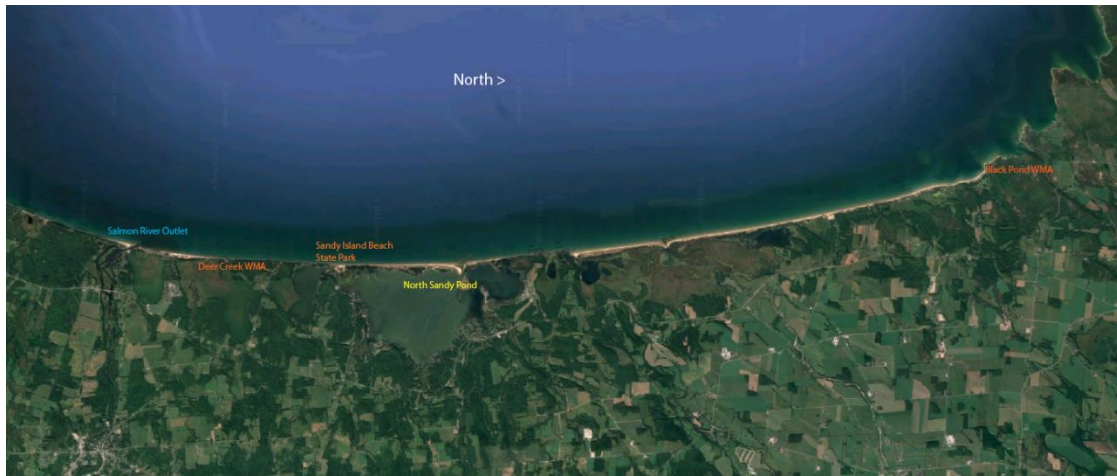
Figure 1. Map view with North oriented right of Eastern Lake Ontario Dune Complex, showing the entire Eastern Lake Ontario Dune Complex and field trip stops (orange.)

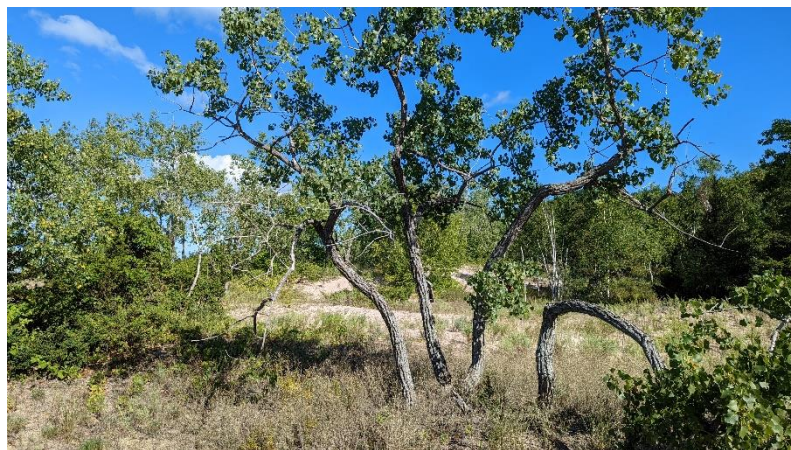
Figure 2. Young cottonwoods mixed in with dune grass populate the interior dune at Black Pond WMA.

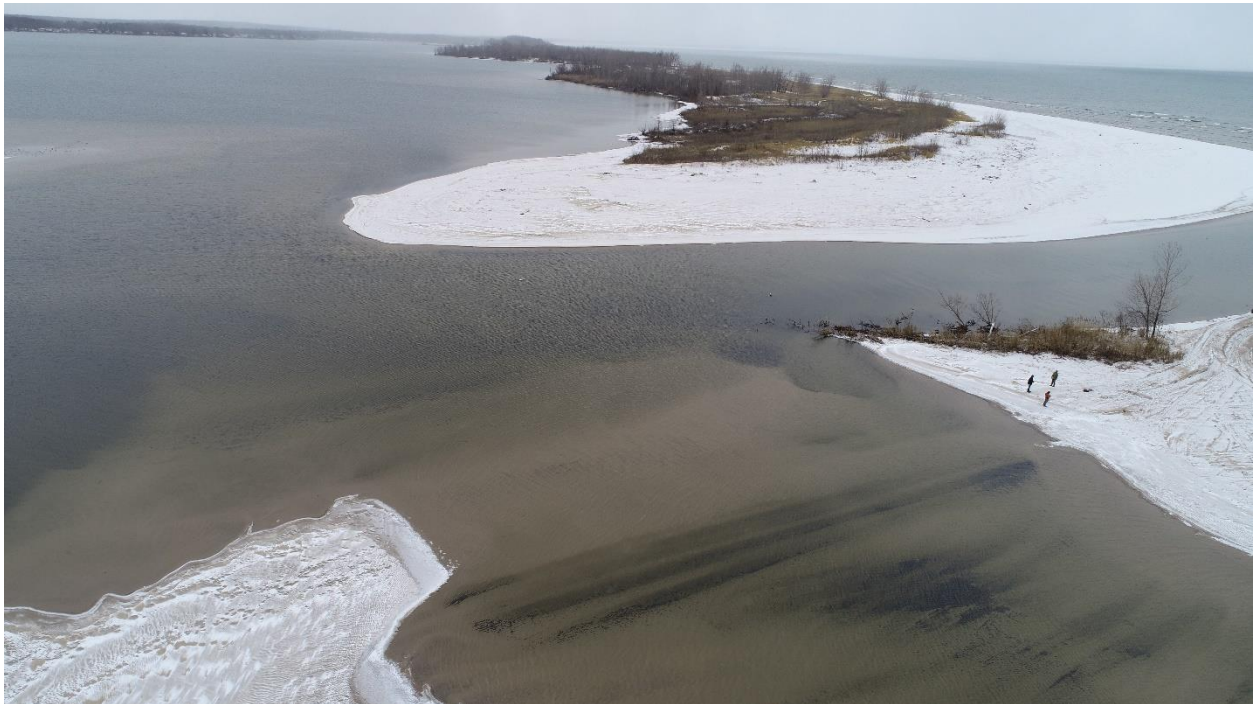
Figure 3. Looking southeast towards the Southern Spit at North Sandy Pond, December 2020. Constant sand transport towards eastern Lake Ontario results in seasonal deposition within the only active inlet to the pond, which is dredged annually by the Town of Sandy Creek and other entities. Dredged material is used to re-nourish breaches within the spit and in dune restoration projects.

Along the North Spit (Figure 10), significant breaches occurred in 2017 and 2019, occurring close to residential properties in the north. Local communities and organizations were mobilized to action, and received grants from the State of New York to begin a dredge-and-place project along the shoreline to repair the breaches in the barrier, install dune fencing to catch wind-blown sediment, and provide numerous spring and fall dune grass plantings with community volunteers. Dredge material is sourced from the nearby North Sandy Pond inlet, where a navigation channel is maintained (visible in Figure 3.)

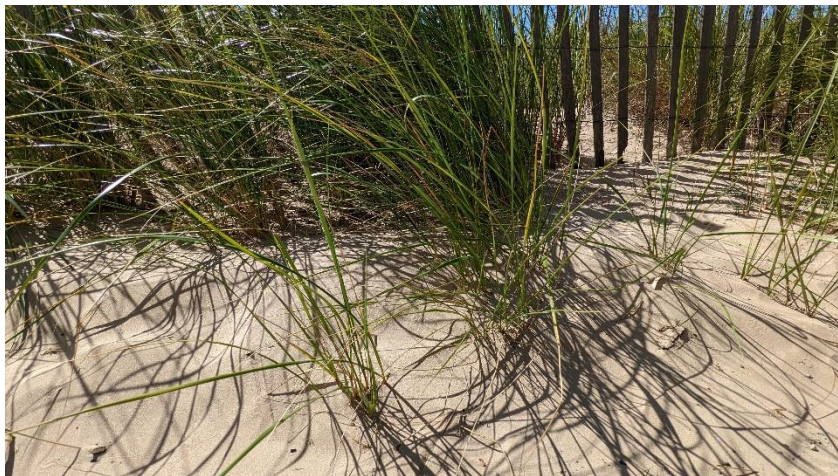
Figure 3. Dune grass and fencing at Southwick Beach State Park, part of a dune restoration project.

At Southwick Beach, significant shoreline dunes were lost in the flooding and erosion as a result of historically-high lake levels in both 2017 and 2019. In order to restore these shorelines to a status worthy of presenting in a New York State park, dune fencing and significant planting of dune grass occurred between 2019-2021, with more plantings planned in the future. This minimalist approach has led to a nearly complete restoration of the previous shorelines. Additional funding and planning has also implemented stormwater basins, grassed waterways and raingardens in and around parking areas in the park to mitigate flooding events in the future.

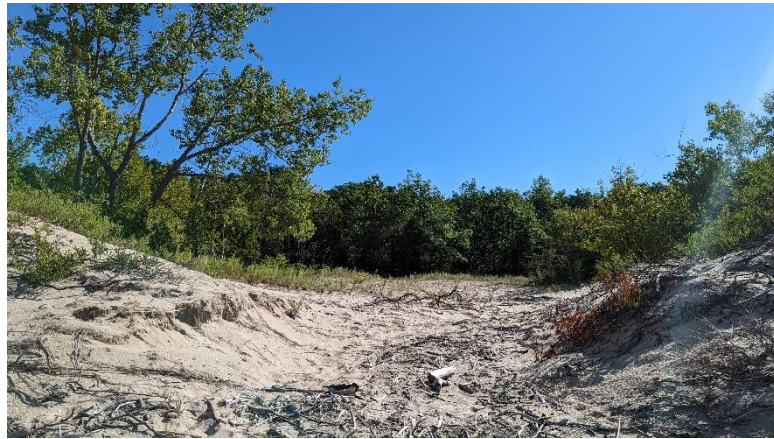
Figure 5: Recent dune blowout at Black Pond WMA.

Across the dune complex, dune blowouts may occur. Blowouts are depressed features within previously-vegetated dunes, where wind erosion has become accelerated and cuts into the dune perpendicular to the shore. In many cases this process is naturally occurring, a result of funneled winds along the shoreline. However, in Oswego County in particular, human activity along the dunes (walking over and destroying dune grasses, motorized vehicle transport, or the erection of buildings along the shoreline) has caused significant blowout events. Overuse of all-terrain vehicles in the 1980s resulted in significant dune blowouts, necessitating the formation of the Eastern Lake Ontario Dune Coalition to attempt to control human destruction of the dunes and to begin conservation programs locally. Remnants of the blowouts, both natural and unnatural, are still visible today and can be seen at Stops 1 and 3 (Black Pond WMA, Sandy Island Beach State Park.) In order to reduce the erosion of sand dunes through dune blowouts, multiple public and private projects have been executed to construct boardwalks or dune overwalks throughout the region, allowing dune grass to live while also securing human access to coastal areas. Additionally, dune fencing is used to slow the transport of sand grains along the shoreline. When coupled with planting of dune grass, dune fencing can help re-establish dunes within 2-5 years.

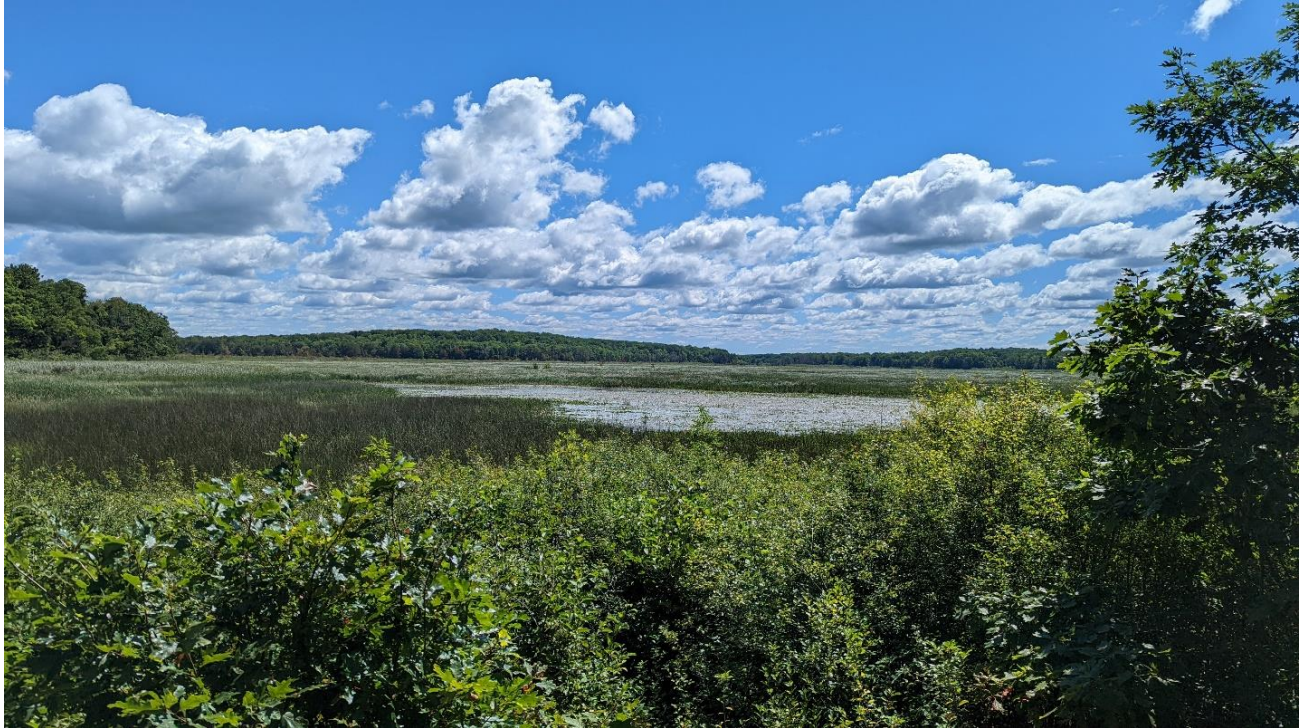
Figure 6. Open water and swamp at Deer Creek Marsh Wildlife Management Area as seen from lookout deck.

In most cases along eastern Lake Ontario, these wetland complexes have formed in areas where drainages meet an elevation impediment near the lakeshore, often the dunes themselves. This is starkly visible at Deer Creek Marsh Wildlife Management Area (WMA, Stop 2.) Deer Creek has headwaters just south of the Winona State Forest in Sandy Creek, but drains a significant portion of Oswego County before entering the WMA, a 1771 acre marsh, nestled between NYS-3 and shoreline dunes. The creek itself bends southward once meeting the dunes, and travels south for around 1 km before reaching Lake Ontario, where the creek only seldom drains into the lake directly. Reworked lake sediments often form a complex transitional area at Brennan Beach (private) impounding the creek.

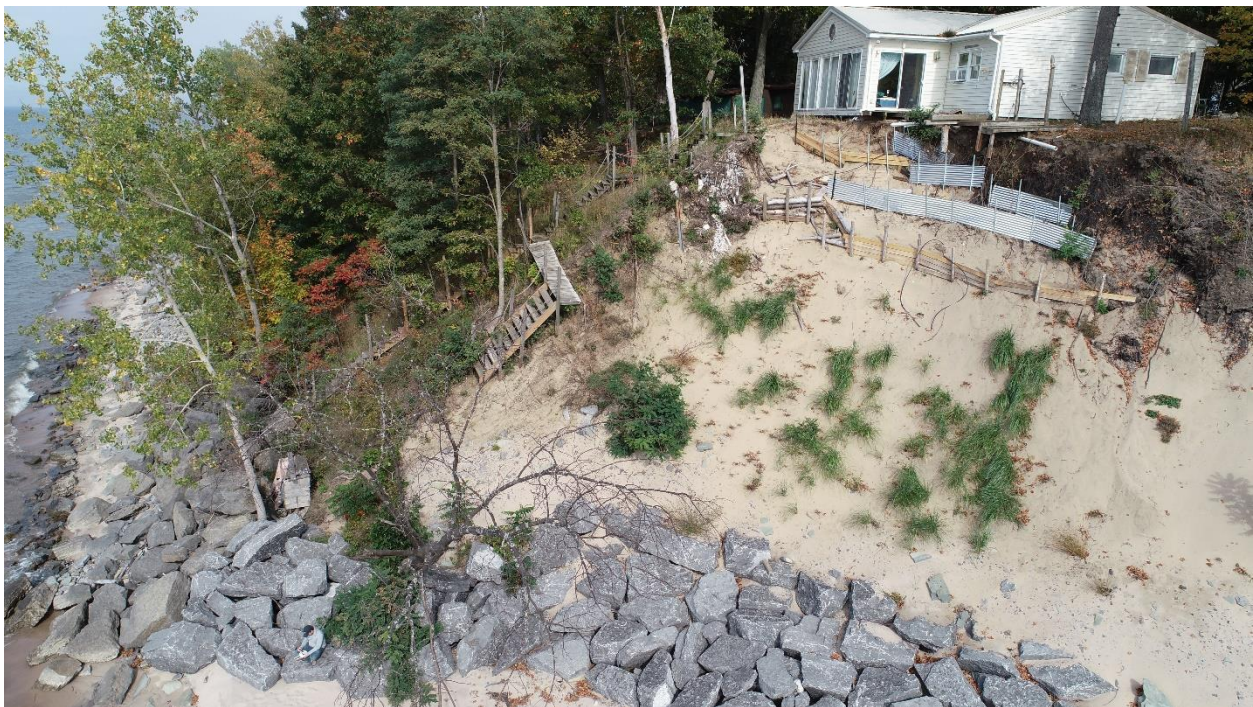
Figure 7. Limestone rip-rap and dune revegetation on display along the south spit, October 2021.

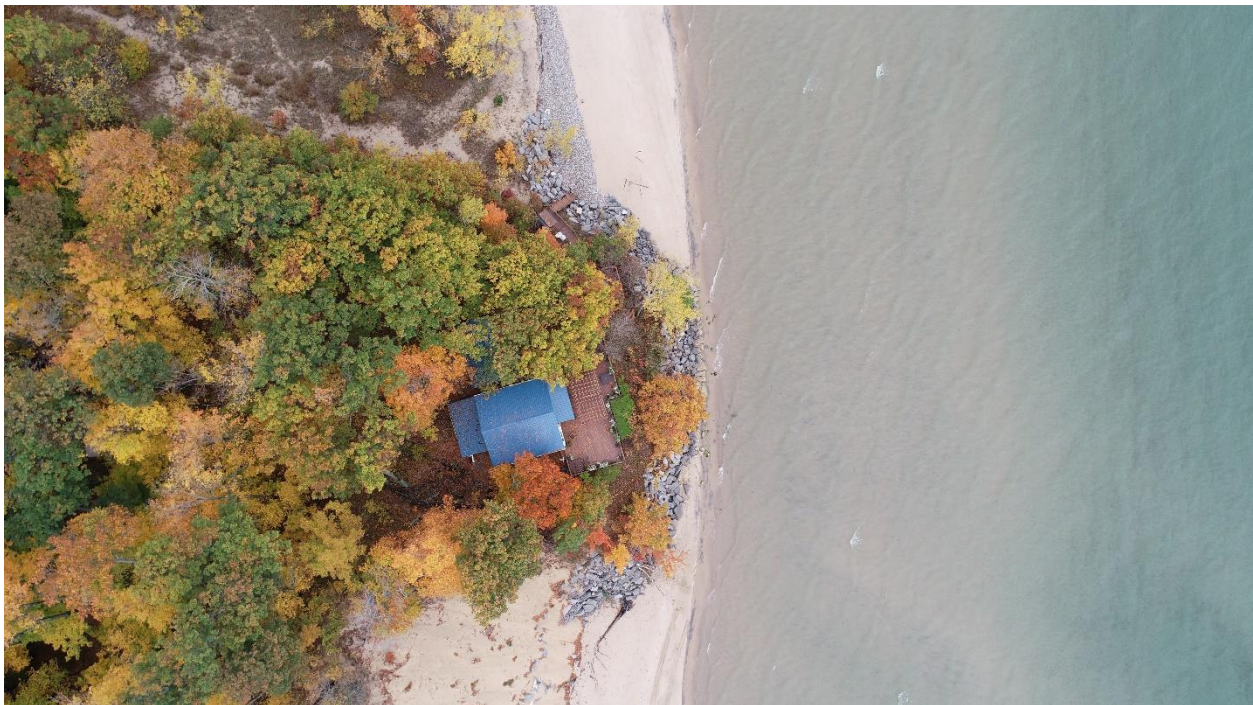
Figure 8. Headland created by artificial shoreline stabilization techniques, South Spit of Sandy Pond. Here, waves have been deflected away from the shoreline and into unprotected shoreline areas, resulting in additional, accelerated erosion along the flanks of the rip-rap wall.

While heavily engineered solutions to shoreline erosion exist throughout the dune complex, longshore sand transport remains efficient along the eastern shore. However, further hardening of the shoreline may endanger these processes. In many situations, these hard structures along the shoreline act in opposition to the coastal processes needed to maintain the dunes and barrier spit morphology. Hard shorelines often cause scouring at the base of structures, moving sand off the shoreline and out into the lake where it becomes inaccessible to waves, failing to bring the much-needed sediment to the shoreline. Additionally, these walls have been shown to accelerate erosion along adjacent shorelines (Figure 9) and act as a deterrent to beneficial native wildlife (Gittman et al., 2015) and an attractant to nuisance species such as Canadian geese and cormorants.

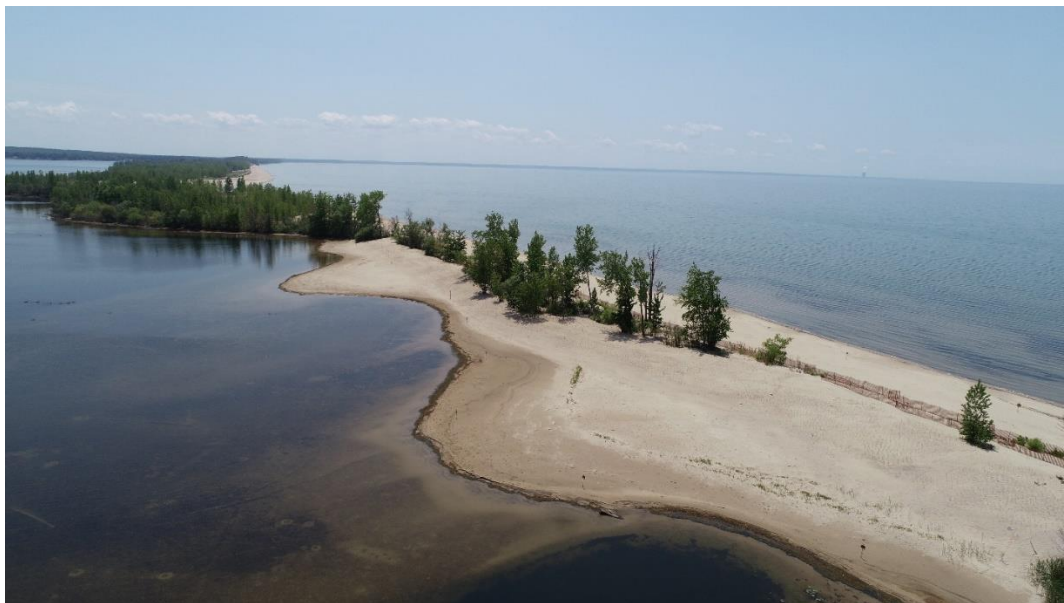
Figure 9. Aerial view of beach nourishment project, north spit of Sandy Pond, Summer 2021. Here, sand dredged from the channel (background, far left) and placed along the shorelines (in front of dune fencing) and

allowed to blow across the narrow spit, depositing in incipient dunes and overwash deposits. Prior to 2019, the spit was wooded along its length, but was washed out completely from storm events in 2017 and 2019.

Through three phases in 2020 a total of 40,000 yd³ of dredged material was placed along the shoreline to repair the breaches. The sediment was almost immediately mobilized by the cross-lake winds, recovering the beach and barrier bar to greater widths than observed in previous years (Figure 10). The barrier is continuously monitored by a dedicated group of volunteers and organizations associated with the Eastern Lake Ontario Dune Coalition and the project is used as a demonstration project for beneficial use of dredged materials and restoration of Great Lakes shorelines through natural and nature-based methods.

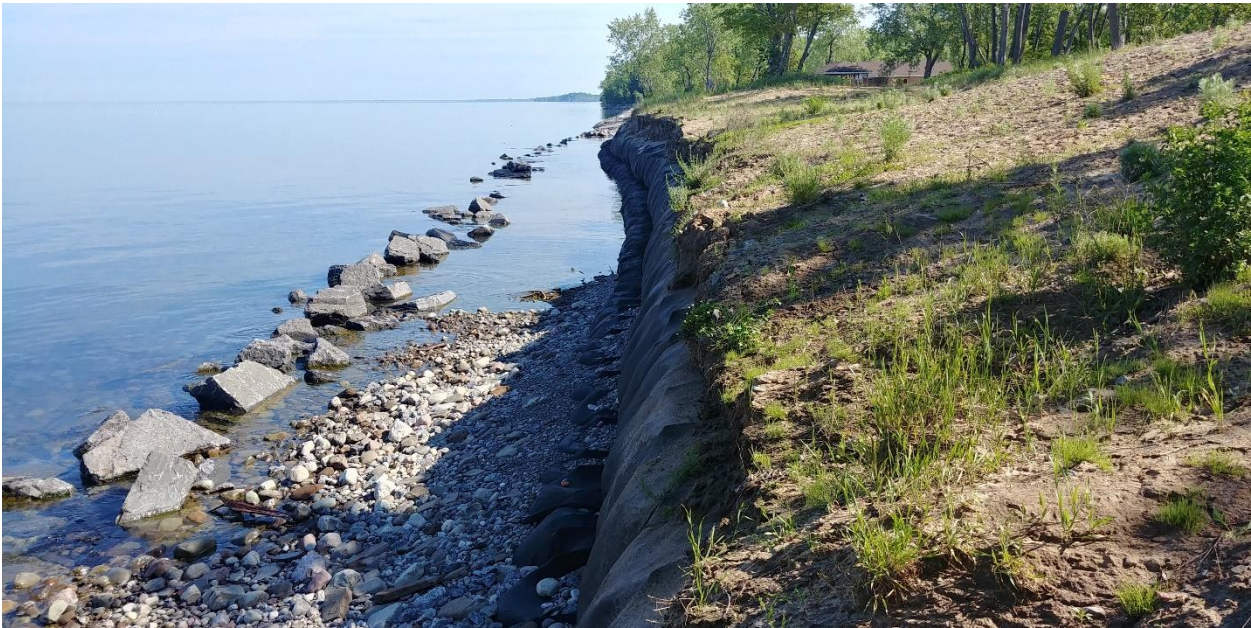
Figure 10. *Failed stabilization attempt at Sandy Island Beach, 2019. Here, large, coarse rip-rap was introduced to reduce erosion of an eroding dune face, but deflected and intensified erosion-causing waves into the inadequate upland sediment (not suitable for dune material) resulting in an immediate and excessive loss of shoreline material.*

In other attempts at shoreline restoration and projection in the Oswego County, there has been less success. At Sandy Island Beach State Park (Stop 3), a combination of heavily-engineered and nature-based features were used to restore the dunes at this location. Similar to the North Spit, the shoreline here was eroded heavily in 2017. However, to maintain local infrastructure including park buildings, an access road to South Pond, and a parking lot, an engineered solution was deemed necessary. This included the installation of trap bags (geotextile bags filled with sand), toe protection through limestone rip-rap, and fill brought in from an upland source. Unfortunately in 2019, water levels exceeded previous highs witnessed in 2017, and the rip-rap was quickly overtopped by waves, eroding the filled material up to the installed trap bags, resulting in a significant loss of land (Figure 11.) Additionally, the upland sediment source used as fill was not suitable for dune-building, and was unable to be entrained within the winds enough to contribute to the success of the dune grass plantings, which have struggled. This location is now being studied extensively to develop new solutions to the local erosion issues while maintaining a resilient shoreline for the local infrastructure.
