Hydrologically Active Karst and Disappearing Lake Phenomenon in the Onondaga Escarpment, Western New York

Paul L Richards

SUNY Brockport, Brockport, NY, New York State Professional Geologist No 83

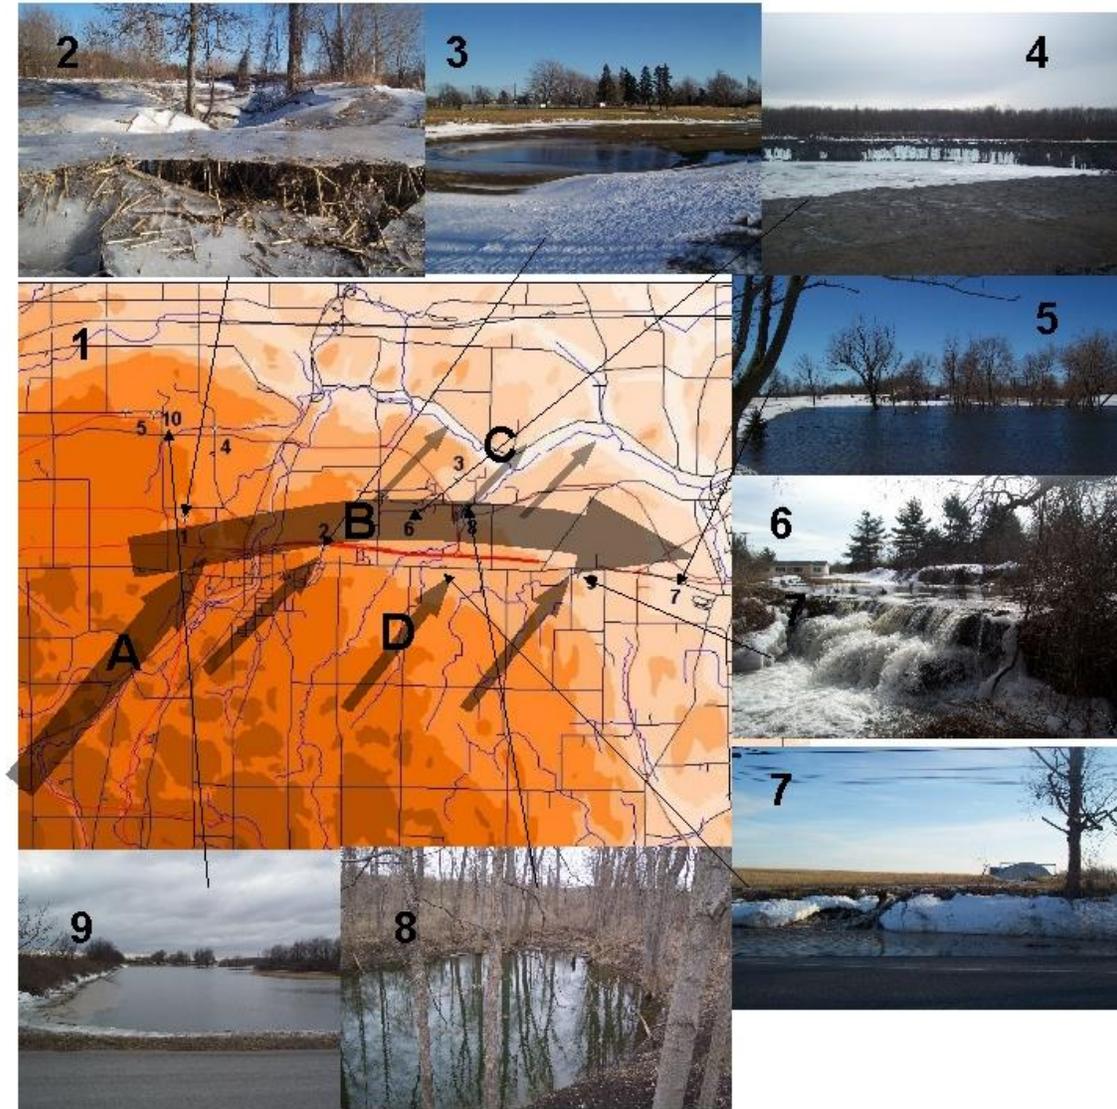
Figure 2. Showing hypothesis for how karst-related flooding may be occurring.

Our interpretation (see arrows in **Figure 2**) is that groundwater flows into the area through a series of northeast fracture traces (**A**). This flow is believed to be shallow and flows on top of the Oatka Creek and Levanna shales, which acts as an aquitard. When the flow reaches the Onondaga FM, the major groundwater flowpath is eastward through East-West fractures toward the Caledonia Springs (**B**) and Spring Creek. Some of this water probably seeps northward into Oatka creek at the base of the Onondaga (**C**); where springs have been mapped along its length. During karst related flood events, a pulse of groundwater causes water tables in the area between Rte 5 and the eastward segment of Oatka Creek to rise. This fills up the abandoned quarries in the region and contributes to the extensive flooding observed at Mud Creek. As this groundwater progresses towards Caledonia it causes water tables to rise in the vicinity of the sinkholes that capture streams flowing from the south sinkholes and other tributaries that terminate inexplicably at Rte 5 (**D**). When surface flows exceed the ability of these sites to accept allogenic recharge, these sites flood. Flooding at New York Bean (in Caledonia), are caused by a combination of groundwater rise and drainage from surface tributaries. The latter features are also probably impacted by urban runoff from Caledonia. Flooding at Britt Rd is probably caused by the low permeability underlying Onondaga bedrock that cannot accommodate runoff and snowmelt.

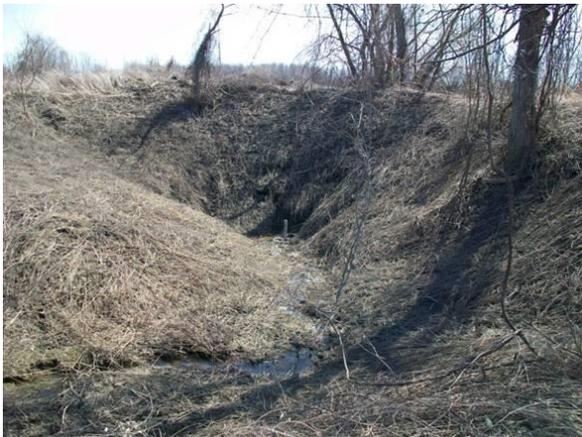
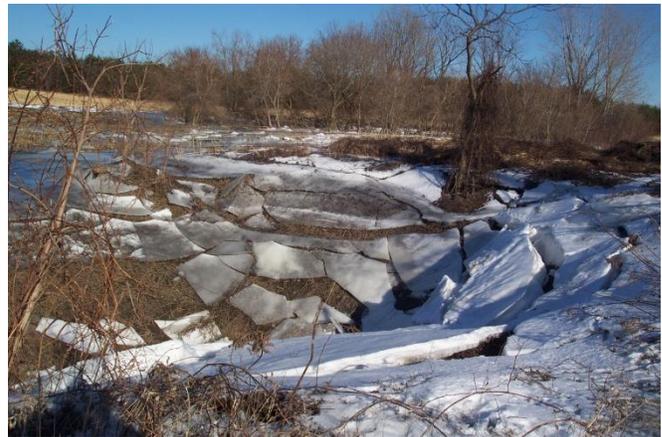
Figure 3. The Quinlan Road Sinkhole.

Most karst features on the Onondaga FM in this region are subtle areas of highly fractured bedrock covered by thin soils. The Quinlan Road Sinkhole site is the rare exception of a deep sinkhole that may be a collapse feature (**Figures 3,4**). The feature receives runoff from a drainage ditch along a nearby cropfield. During Karst-related flooding events, flow into the swallet reverses and groundwater spills out of the feature, flooding the land outside (see figures below). Floods can sometimes flood over Quinlan Road itself. The feature and its flooding were first studied

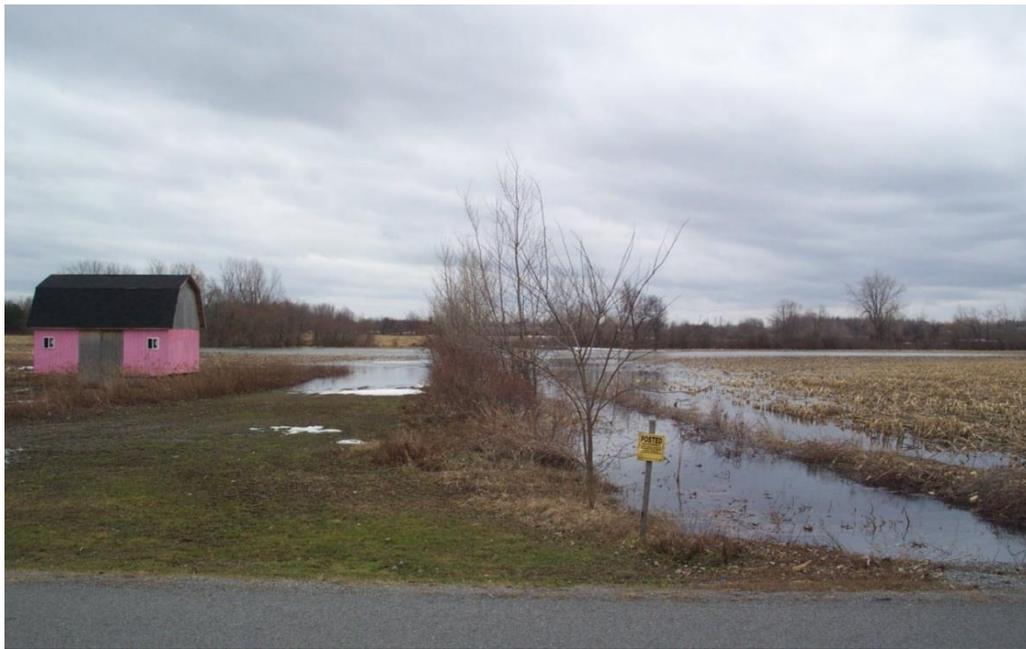
Figure 4. Quinlan Road Sinkhole during Flood Stage.

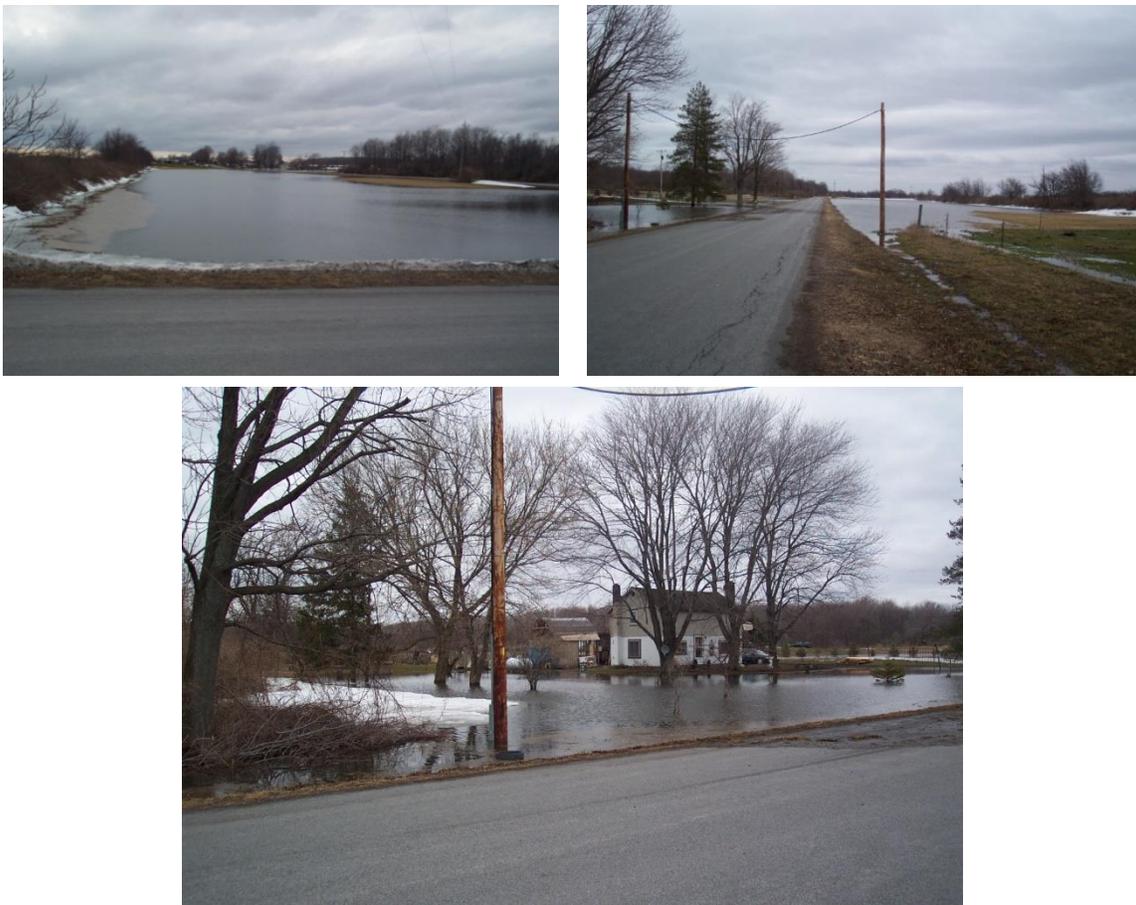
Figure 5. Britt Road site during Flood Stage.

This site does not contain any visible karst features or sinkholes. It floods, however, whenever The Quinlan Road Swallet and the Leroy Golf Course Sinkhole floods (**Figure 5**). A Master's Thesis by Simons and Voortman (2009) developed watershed models for this site and the Quinlan Road sinkhole site. Uncalibrated model simulations indicate that flood water from Britt Road is dominantly surface runoff. In contrast, simulations on Quinlan Road revealed that a high percentage of floodwater was groundwater. Due to the lack of any surface karst features

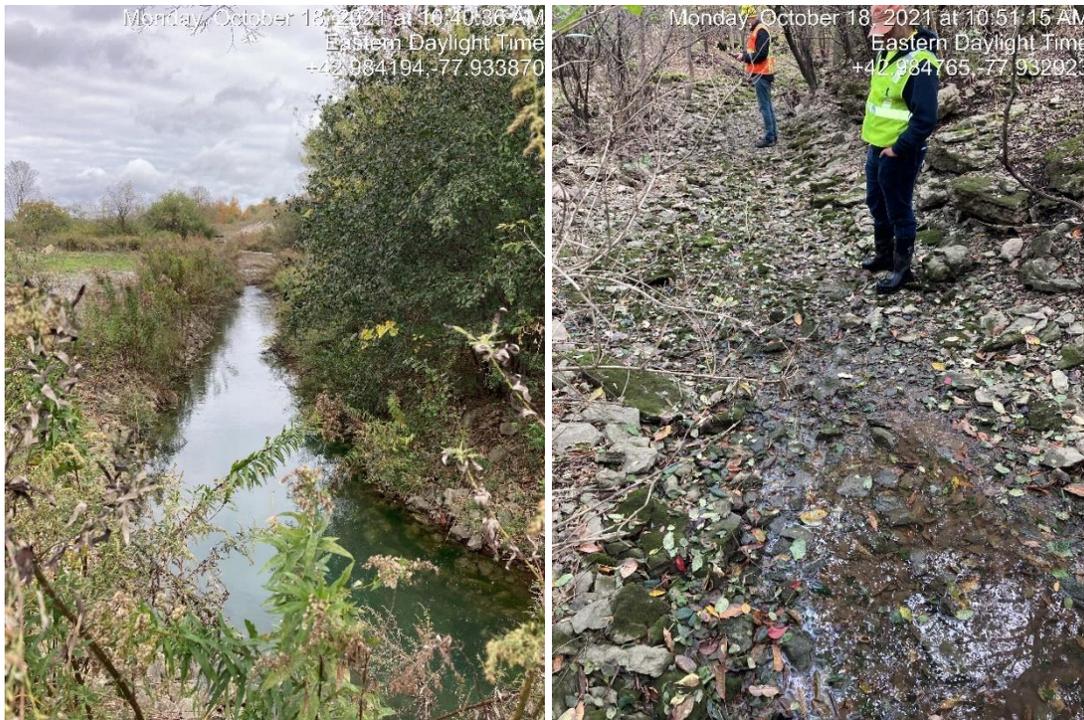
Figure 6. Dolomite Products SPDES outfall into Mud Creek (left). Discharge disappearing into the Mud Creek streambed a few hundred meters downstream of the outfall (Right).

In this region, Mud Creek is the only stream that crosses completely over the Onondaga escarpment, except for Oatka Creek. The stream flows along a major fracture trace. This narrow bedrock stream is heavily fractured and contains many small sinkholes along its length. The flow here is non-existent during most of the year, despite that it receives flow from the Dolomite Products SPDES outfall, which releases an average of 4.5 cfs continuously into it (**Figure 6**). It is subject to karst-related flooding in the

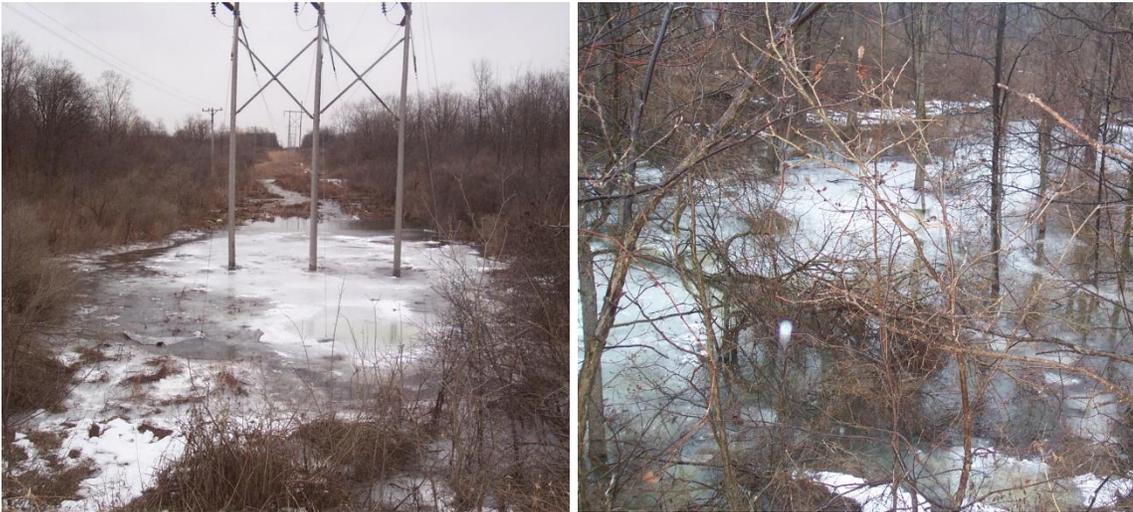
Figure 7. Karst related flooding along Mud Creek (Left) and at the Mud Creek Sinkhole (Right).

segment overlying the Onondaga Escarpment (**Figure 7**). Flow from the SPDES outfall typically disappears within a hundred meters of its outfall. During events and spring runoff, the stream will flow all the way into the Mud Creek Sinkhole. We will be visiting two sites in this feature: the Mud Creek Sinkhole, which is the swallet that captures most of the flow in this system and the canyon north of Golf Road, where the character of the streambed, fractures, and smaller sinkholes can be seen.

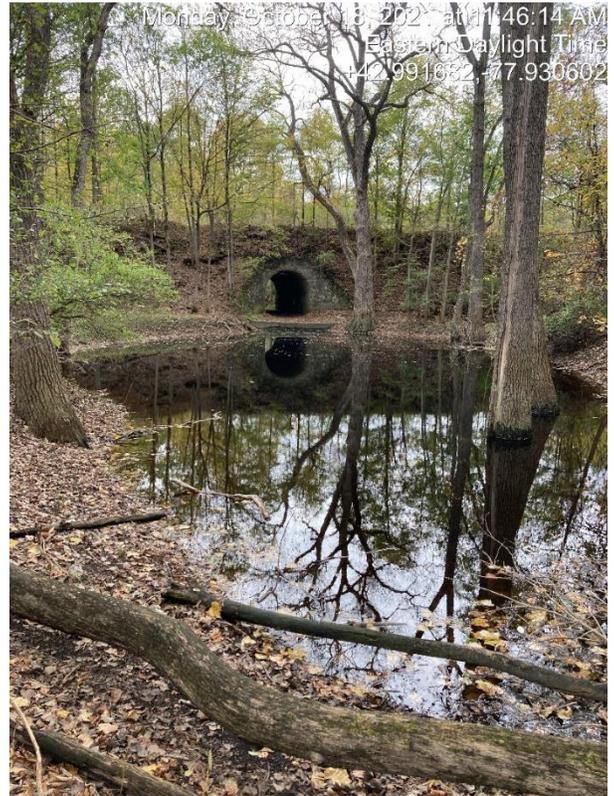
Figure 8. Water Table within the Mud Creek Swallet. Mud Creek flows into this feature through the railroad culvert.

This large circular feature is located just north of the tunnel underlying the LVRB tracks (**Figure 8**). The regional water table is exposed in it. The feature receives all of the runoff from Mud Creek Watershed, which is a 30 sq km watershed. The feature was instrumented with a water level recorder in 2008 and discharge measurements before and after indicate that almost all of the water from Mud Creek watershed disappears in this feature and flows East towards Spring Creek. Only when the water table rises above it during karst flooding events, does water pass this feature and flow along Mud Creek Canyon to its outlet in Oatka Creek.

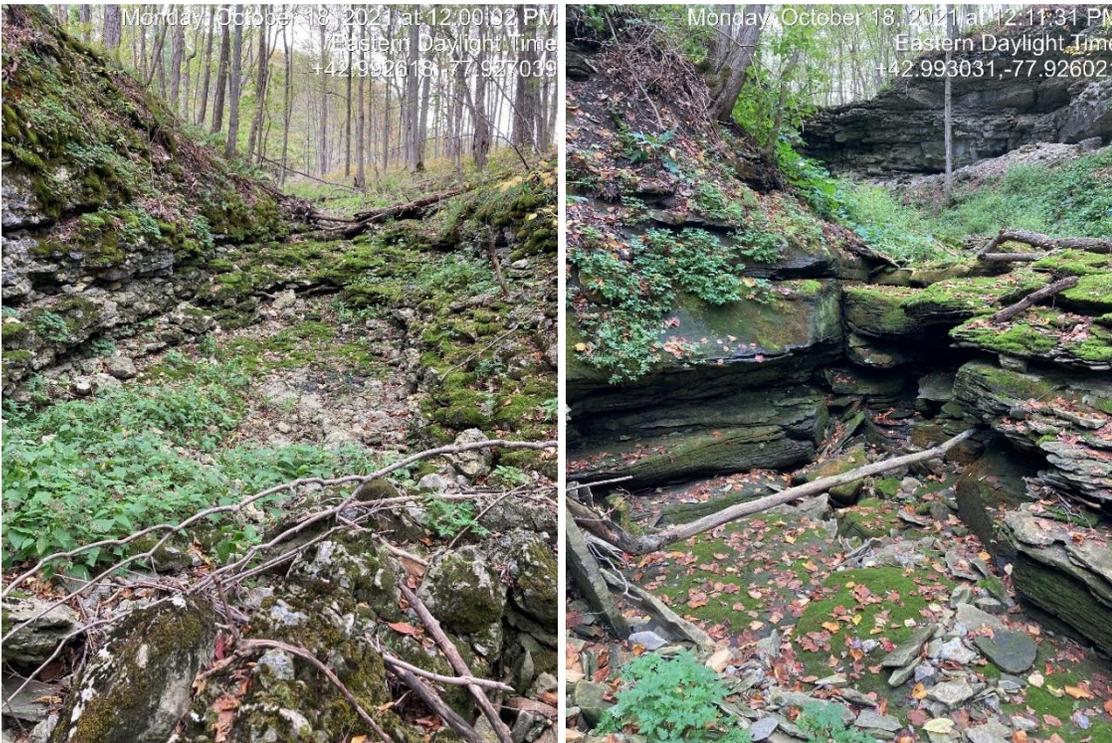
Figure 9. Sinkholes developing in the Mud Creek streambed.

At this site, we will walk along the exposed bedrock to see one of the many smaller “sinkholes” caused by enhanced weathering at the intersection of fractures (**Figure 9**). Because most of the water disappears in the Mud Creek Sinkhole, the creek bed here receives very little flow. It runs only during the most extreme snowmelt or karst-related

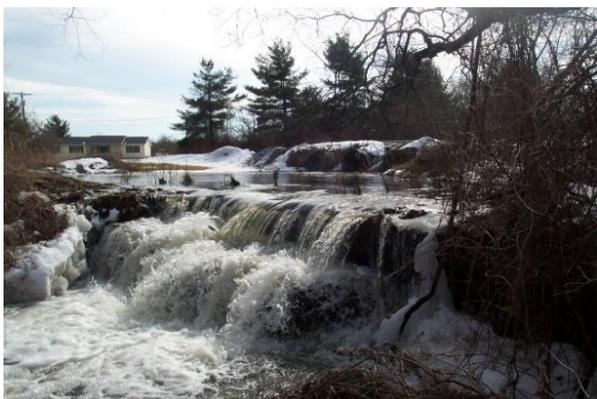
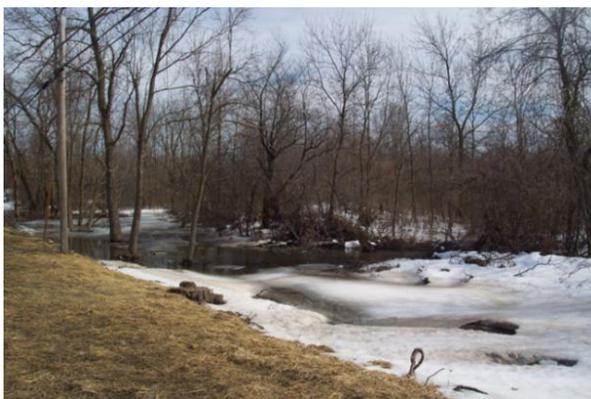
Figure 10. Photos of the Rte 5 Sinkhole during flood stage.

A small unnamed tributary with a watershed area of 9.2 sq km flows into this feature which consists of a waterfall made up of in situ bedrock (**Figure 10**). After the waterfall, the flow is lost in the wetland. The feature sometimes floods

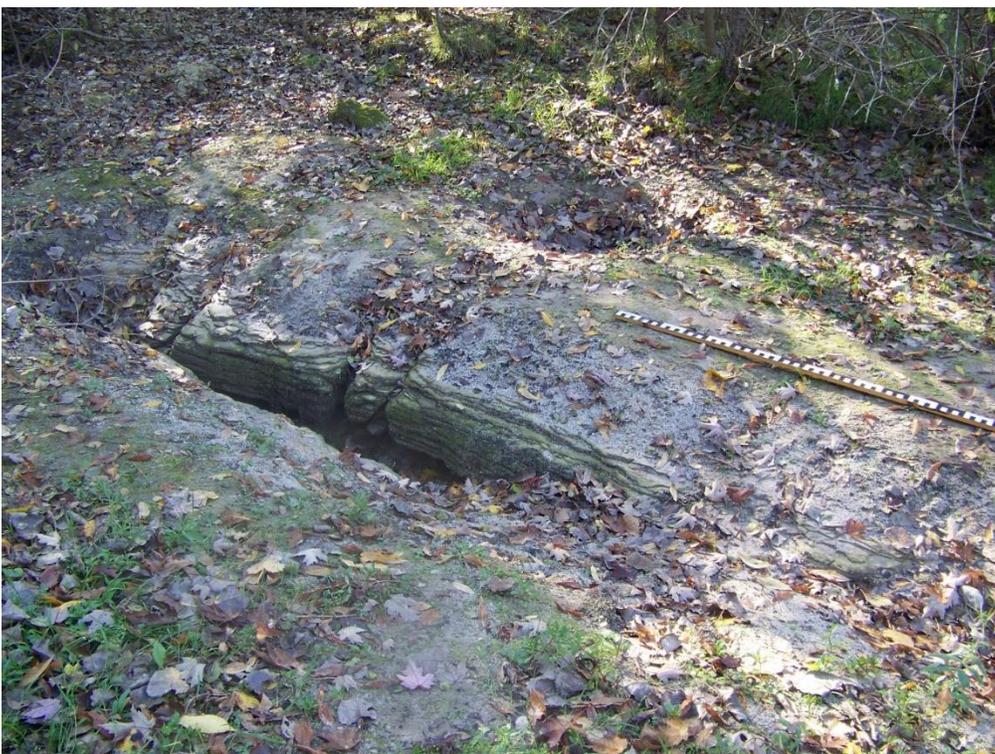
Figure 11. Photo of one of the many large open fractures that underly Mackay Spring.

Mackay Spring rarely dries up. It is shallow and underlain by open fractures in Akron Bertie bedrock that are as wide as 10 centimeters (**Figure 11**). Water flows out of these fractures. White speckles of what is presumably calcium carbonate can sometimes be seen in the water if sediment is kicked up within it.
